## 陕西神北聚能热力有限公司

### 燃煤锅炉及辅机系统精细化巡检检查报告

我公司组织技术人员于 2026 年 7 月 13 日-2026 年 7 月 20 日对贵公司两台 46MW 流化床供热锅炉进行系统精细化巡检，检查发现以下问题：

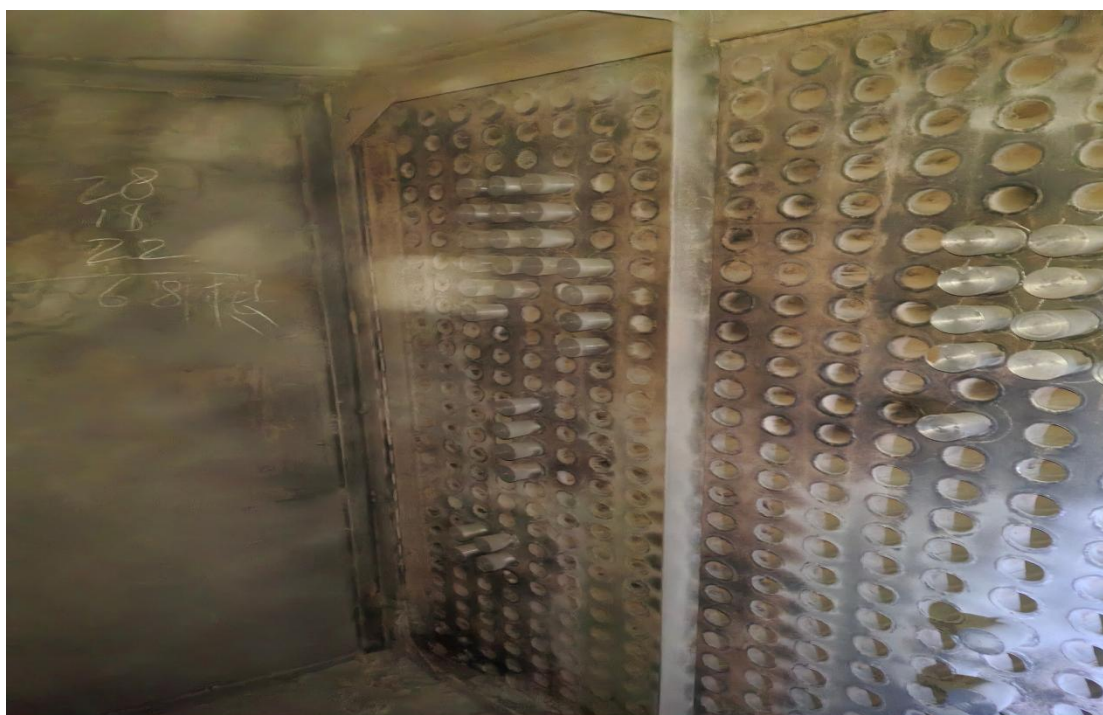
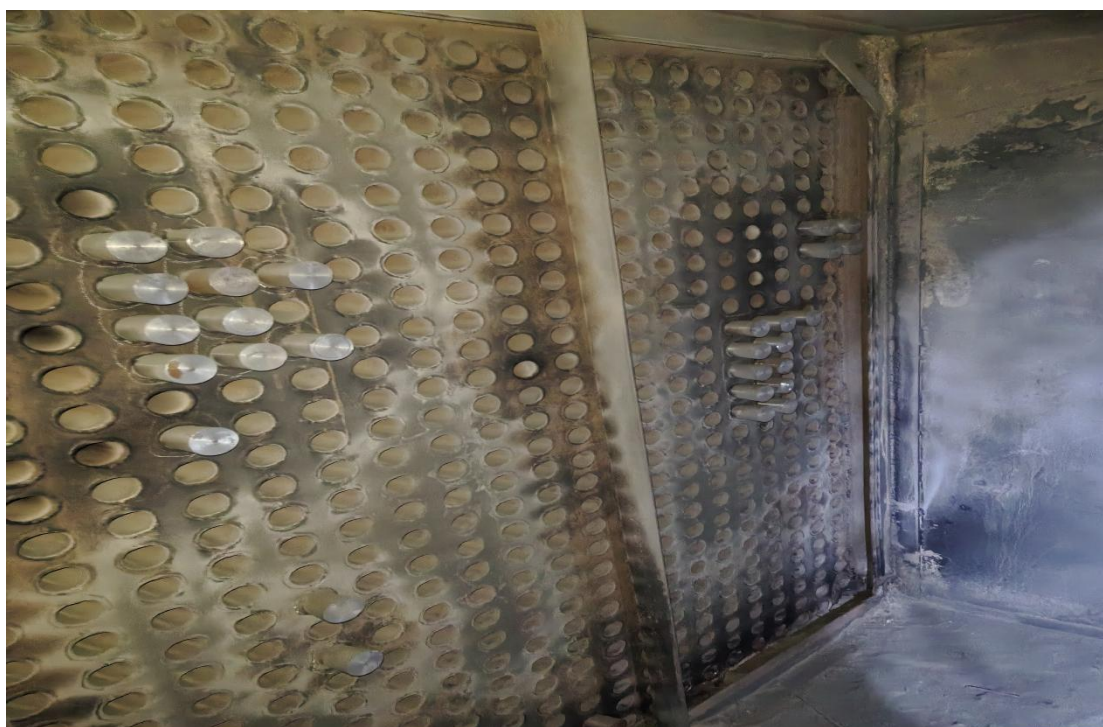
#1 炉：下级空预器现堵漏 168 根，检查未发现有破损的管子；

中层未发现管子破损；

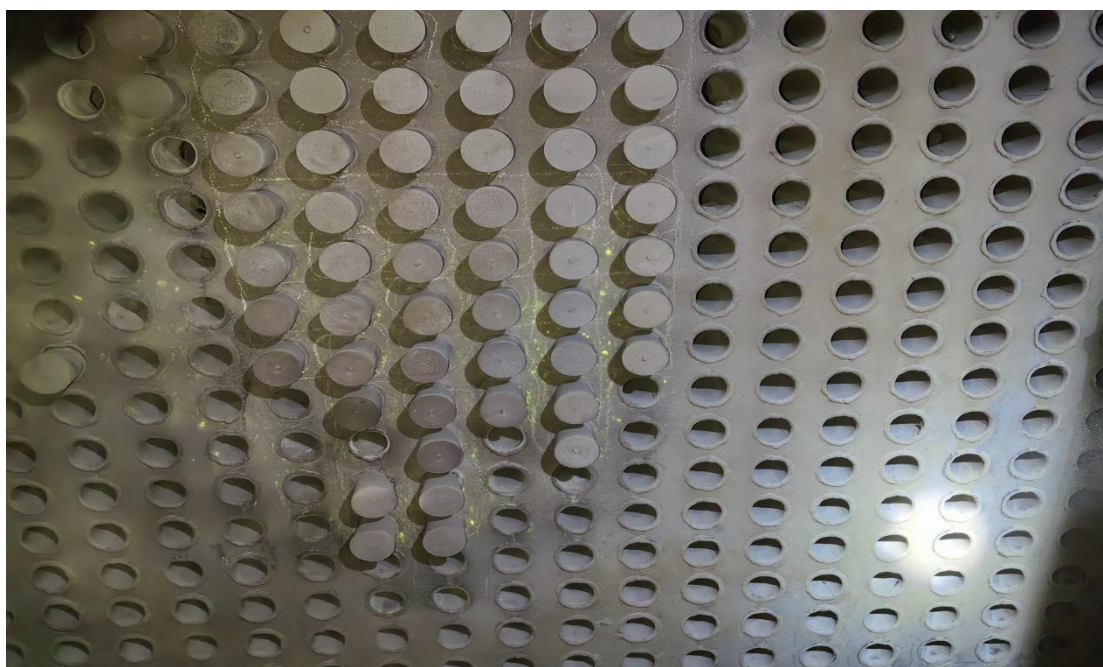
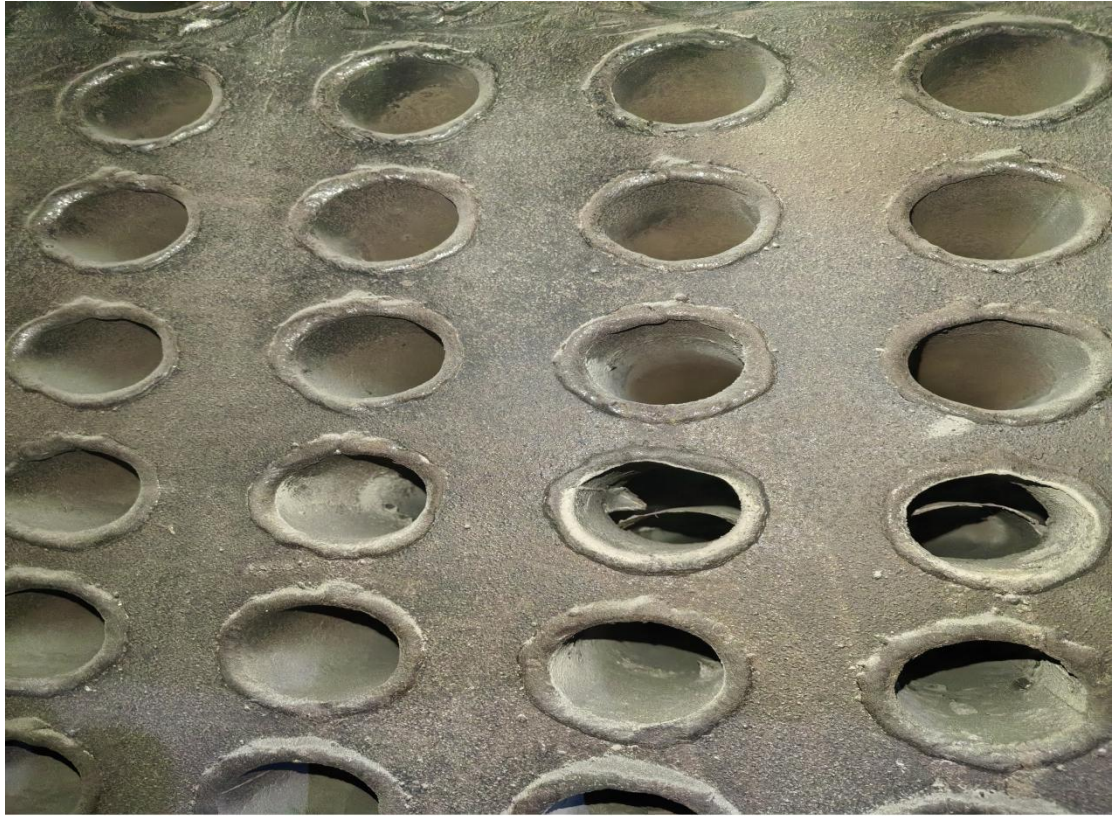
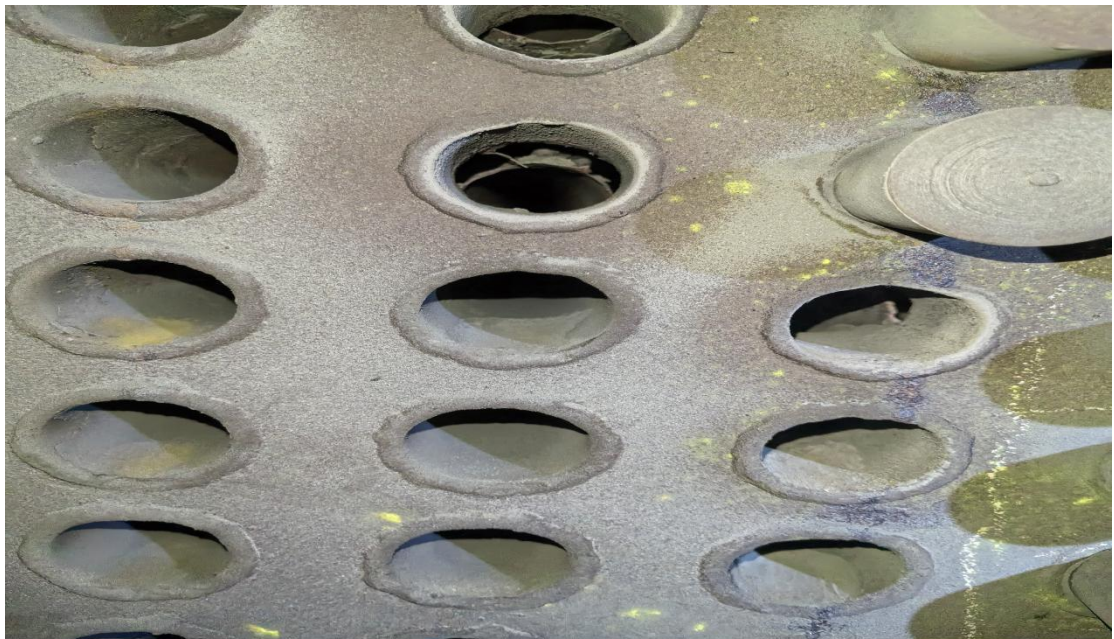
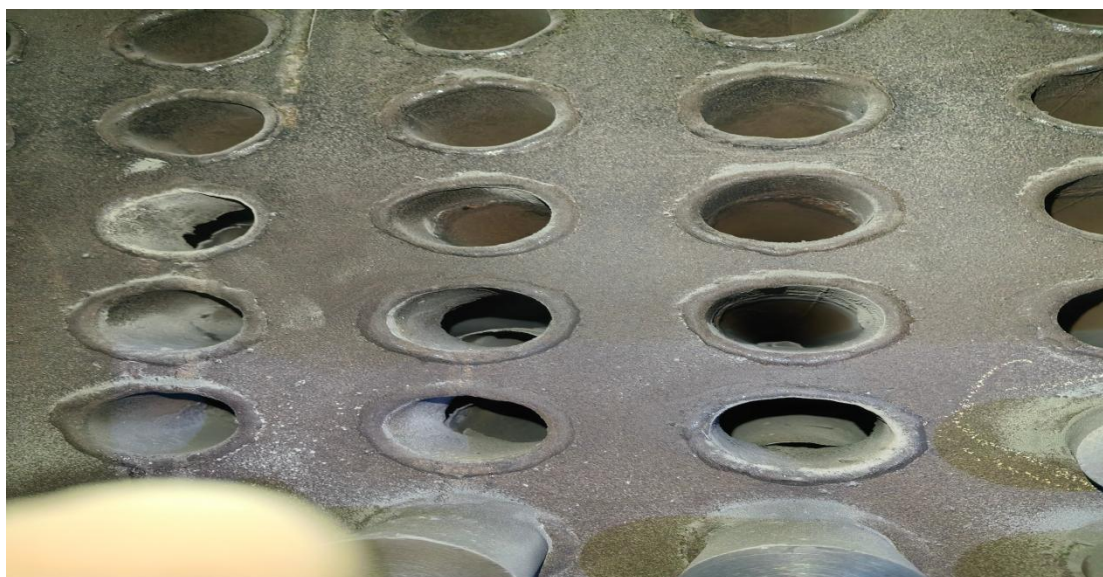
上层已堵漏 128 根，另发现有 15 根管壁破损

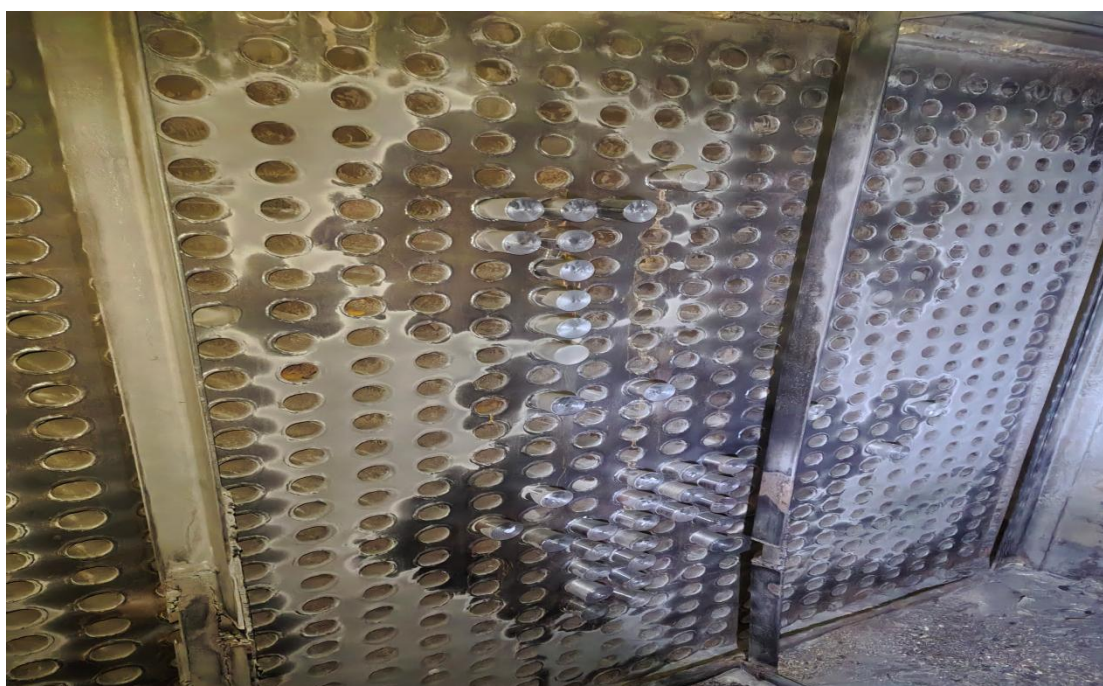
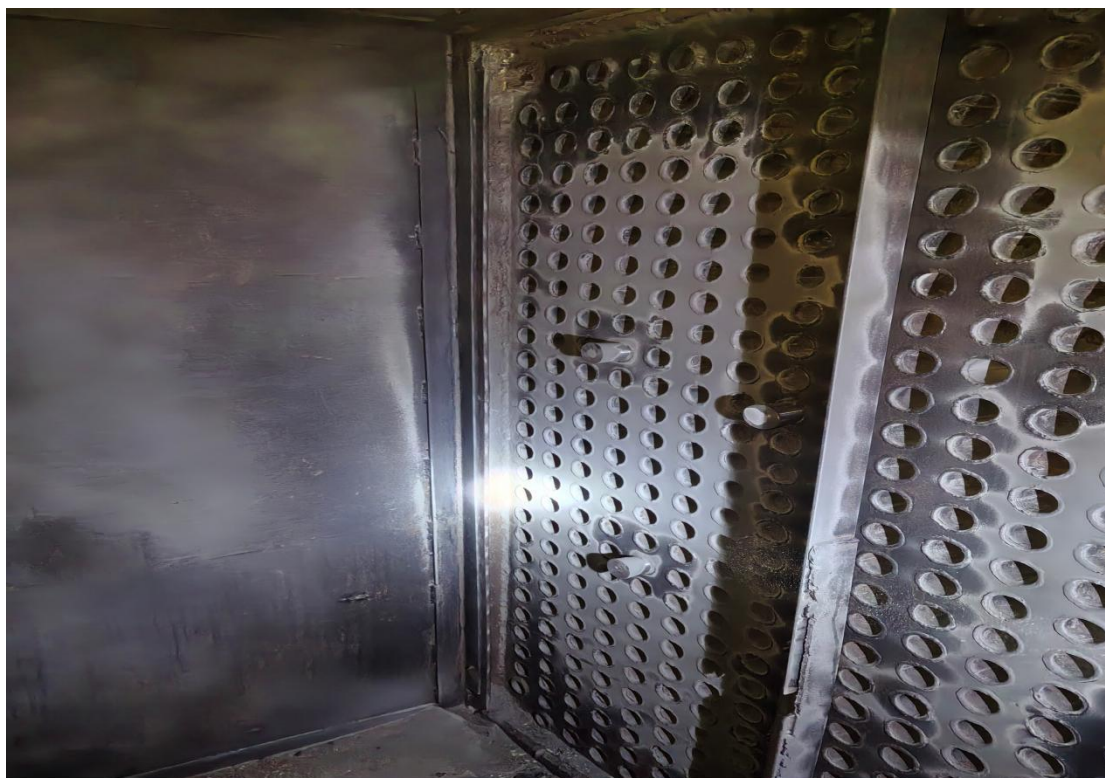
#2 炉：下层有 61 根堵漏未发现破损管子

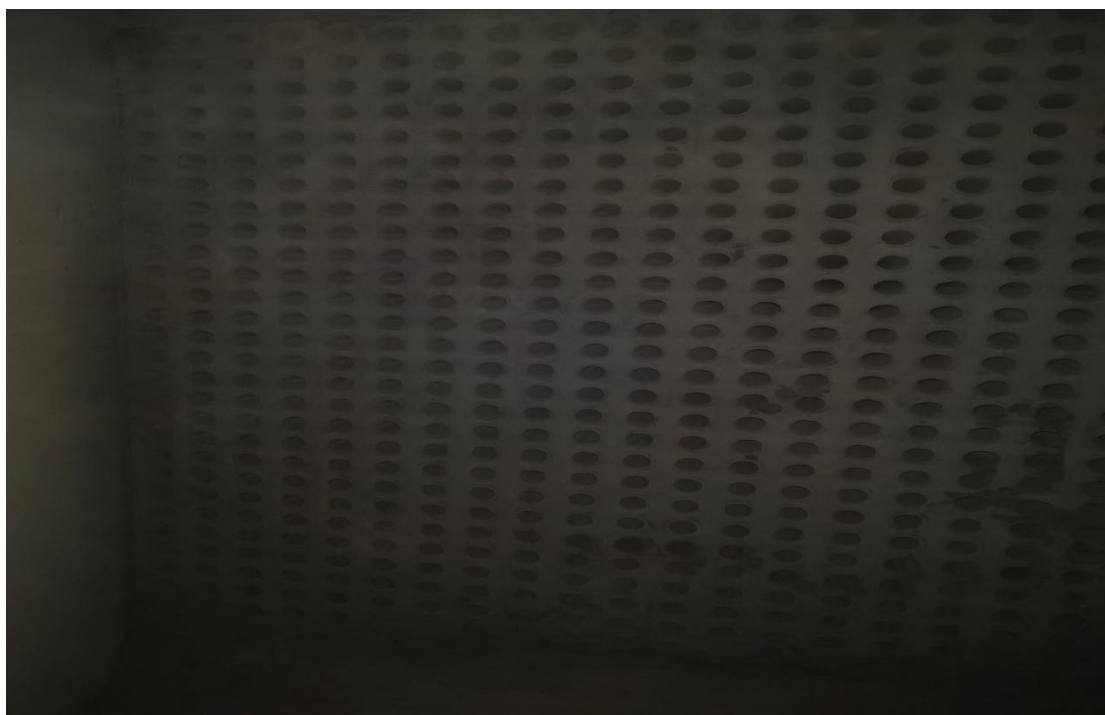
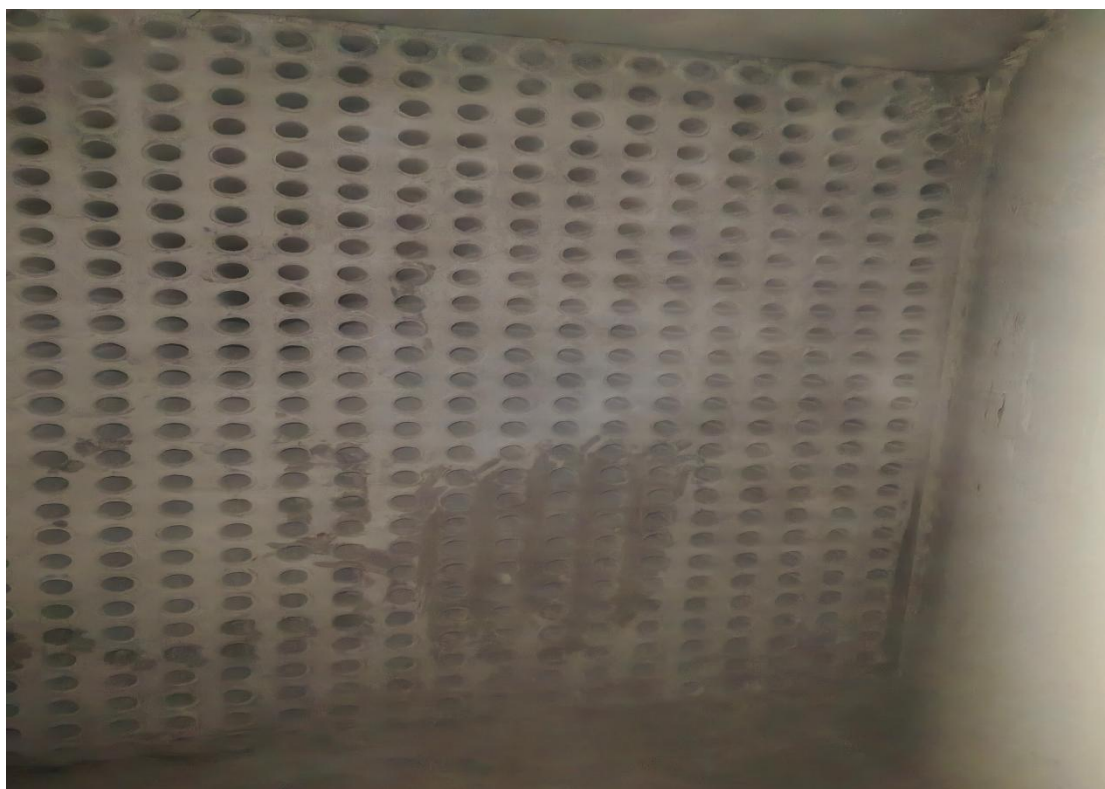
中上层未发现堵漏及破损管子

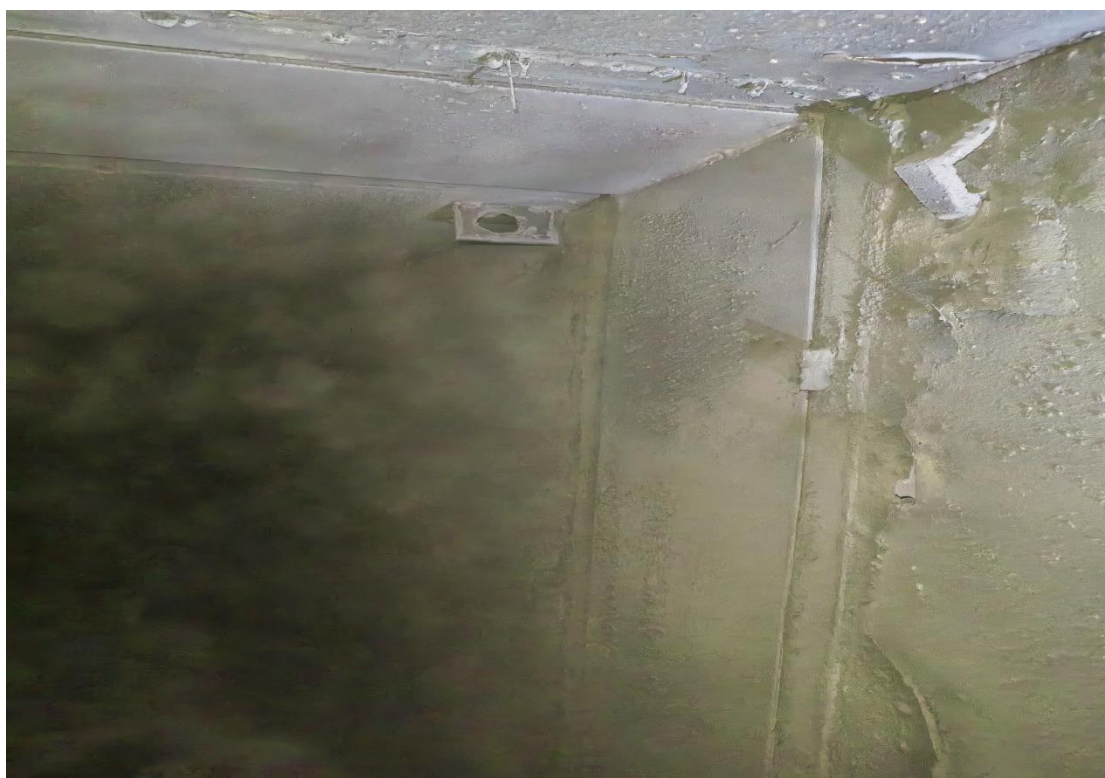
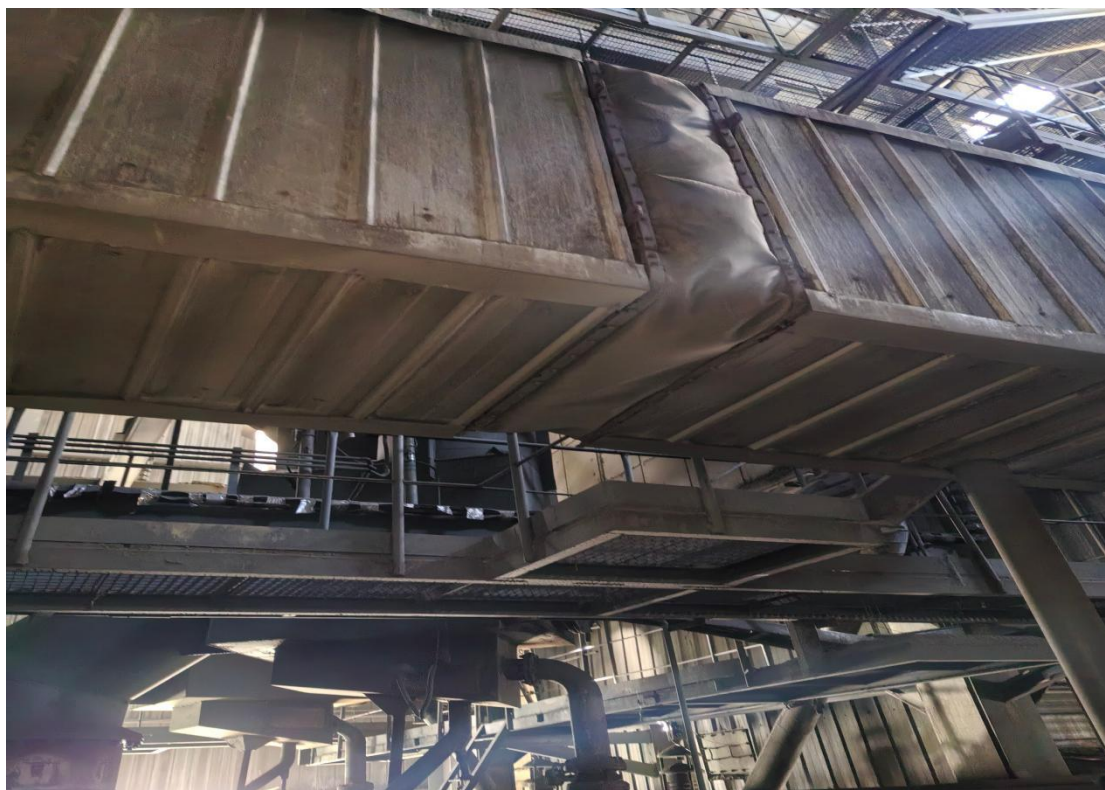
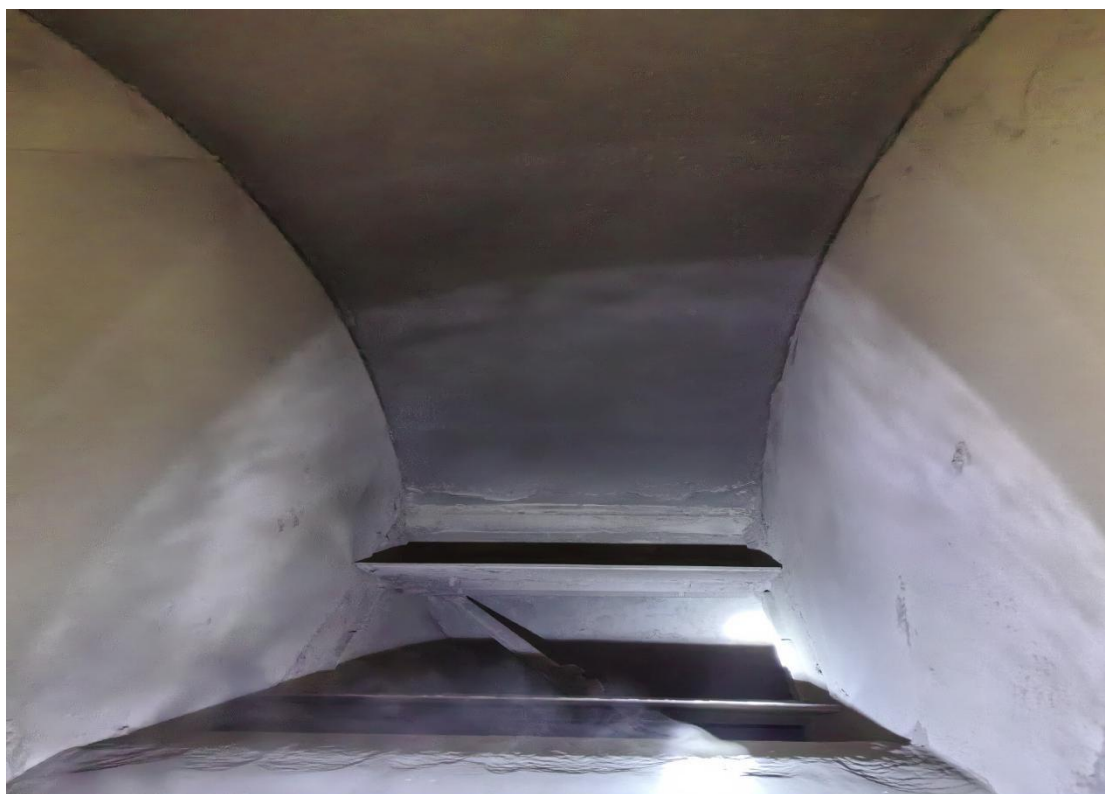
风道未发现破损:

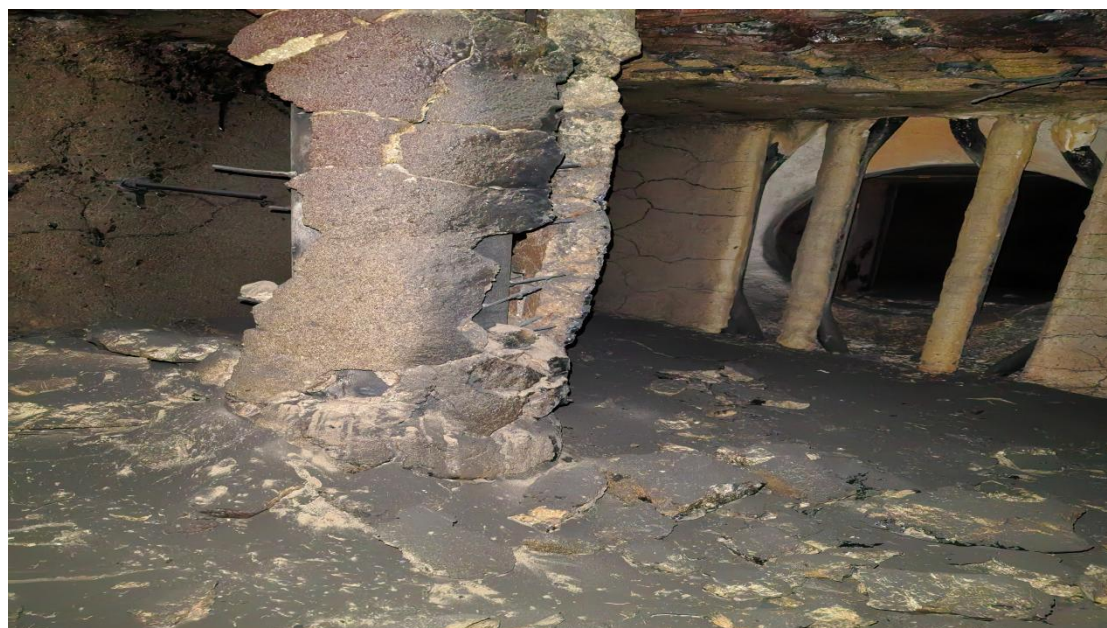
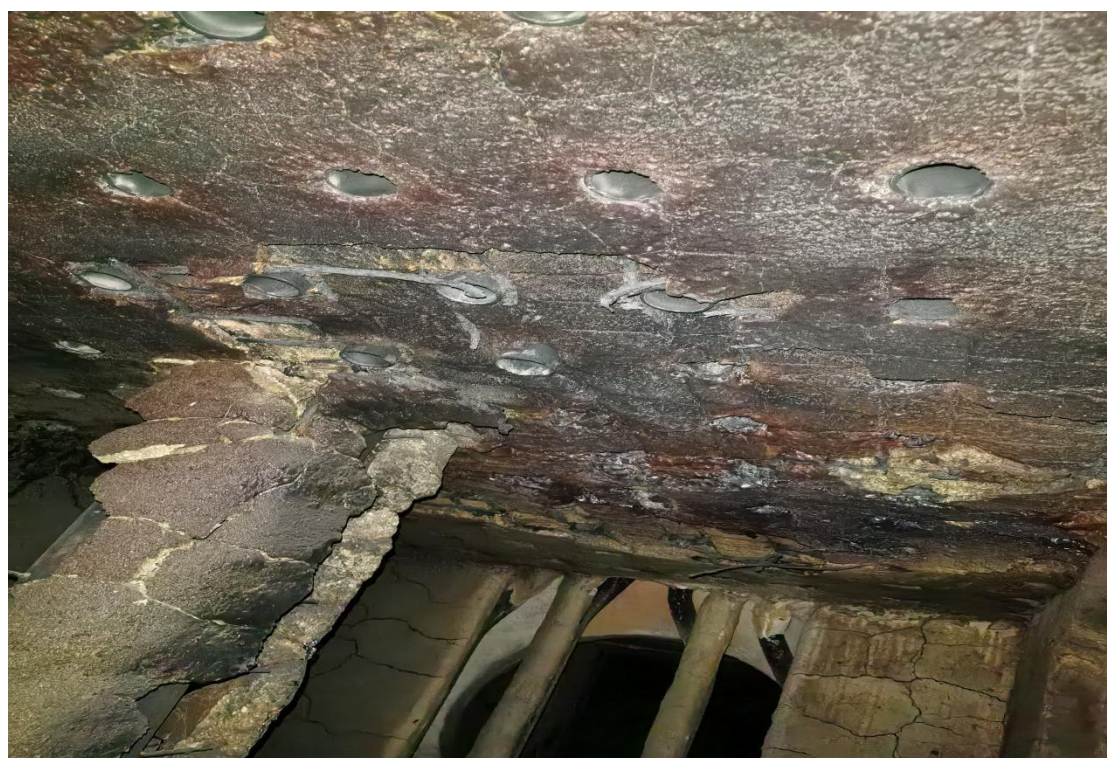
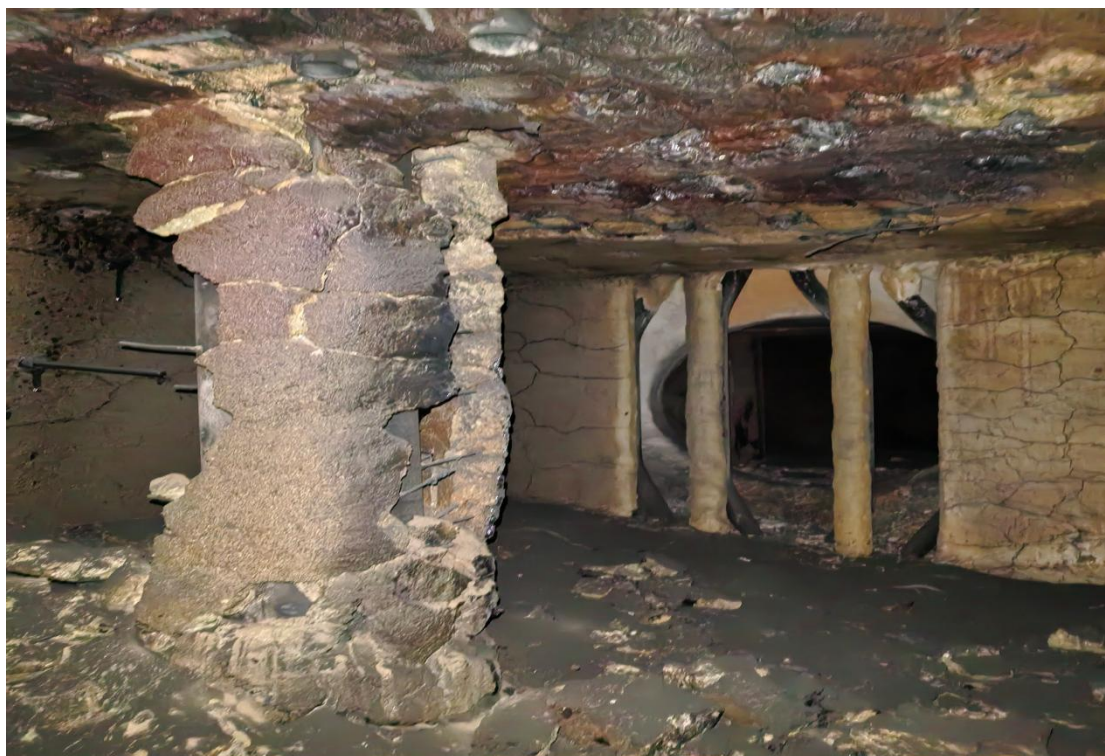
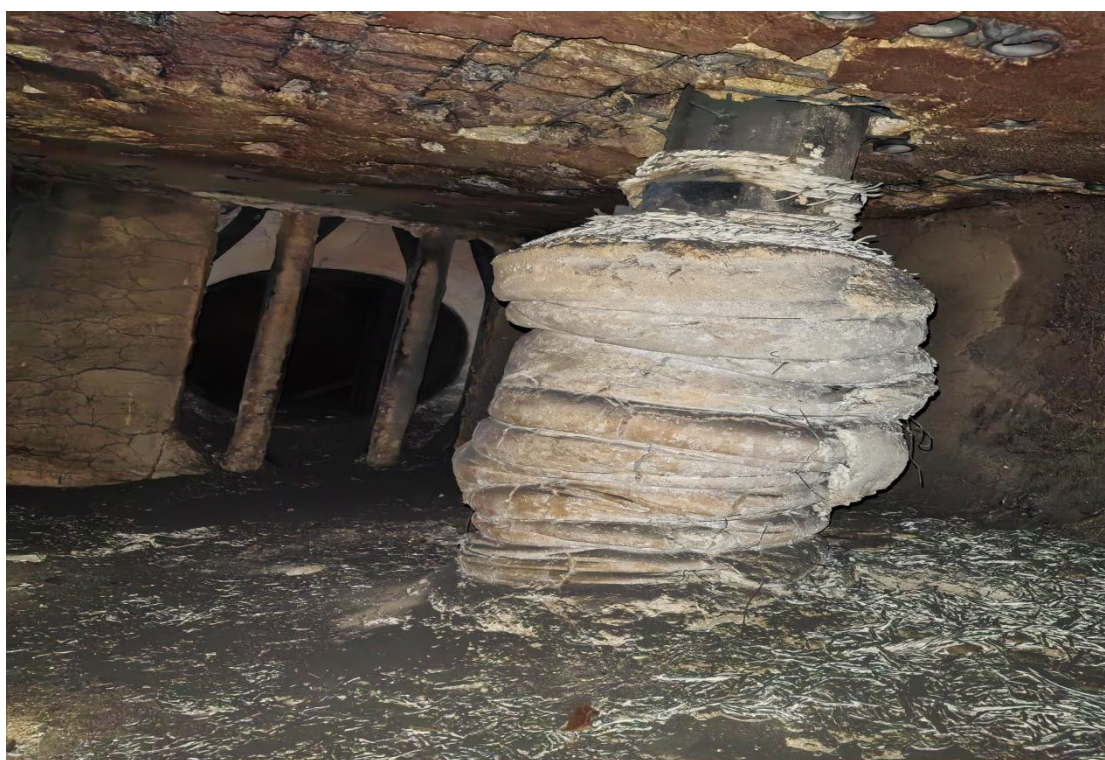
#2 炉：炉门良好，风室内落渣管二根耐火浇注料几乎全部掉落，风室顶部浇注料掉落至爪钉。

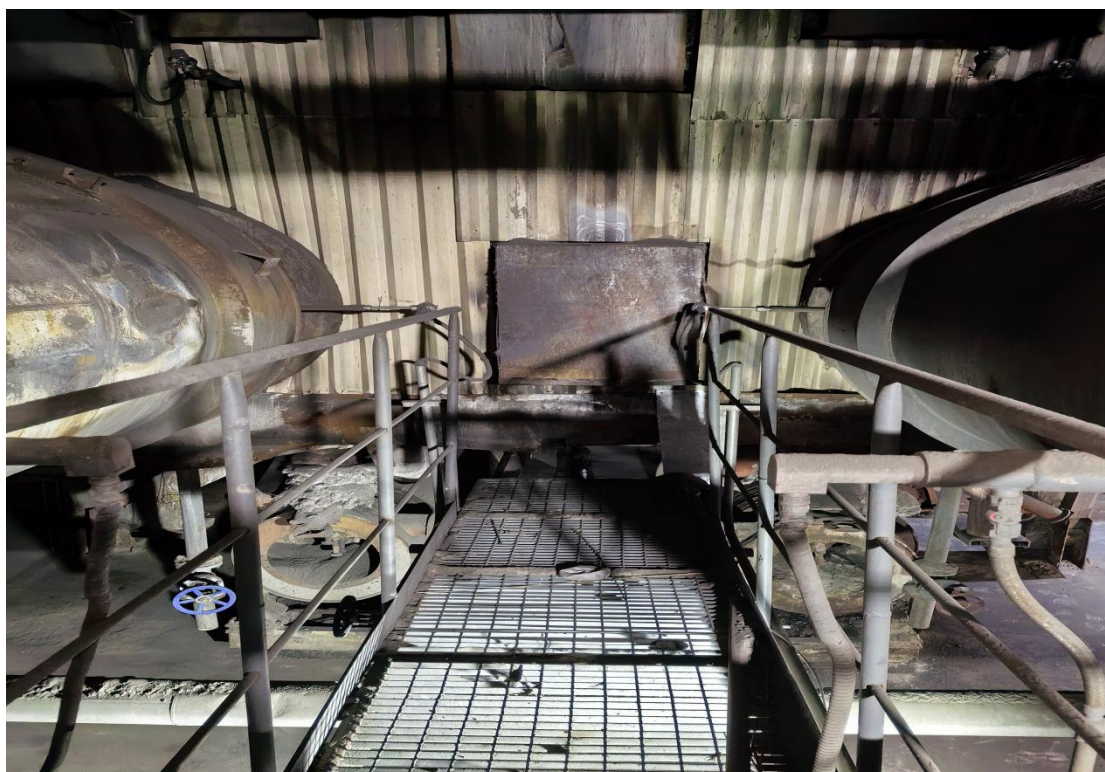
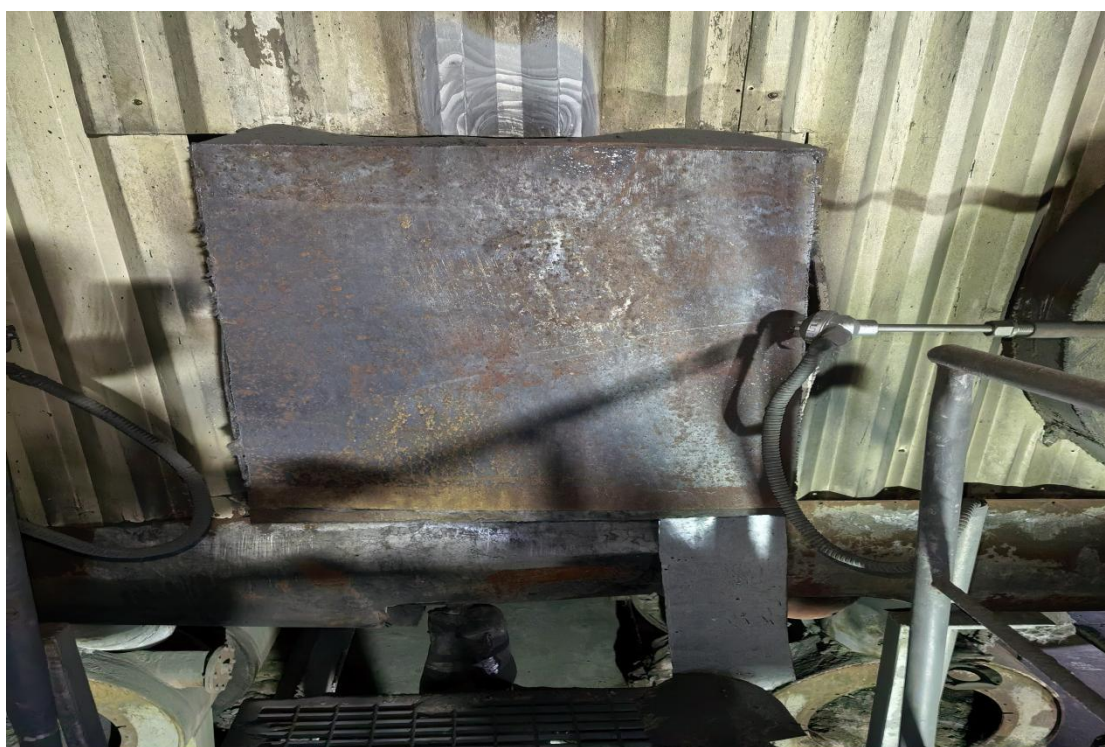
#1 炉：风室检查炉门损坏外部用铁盒焊接无法看到内部

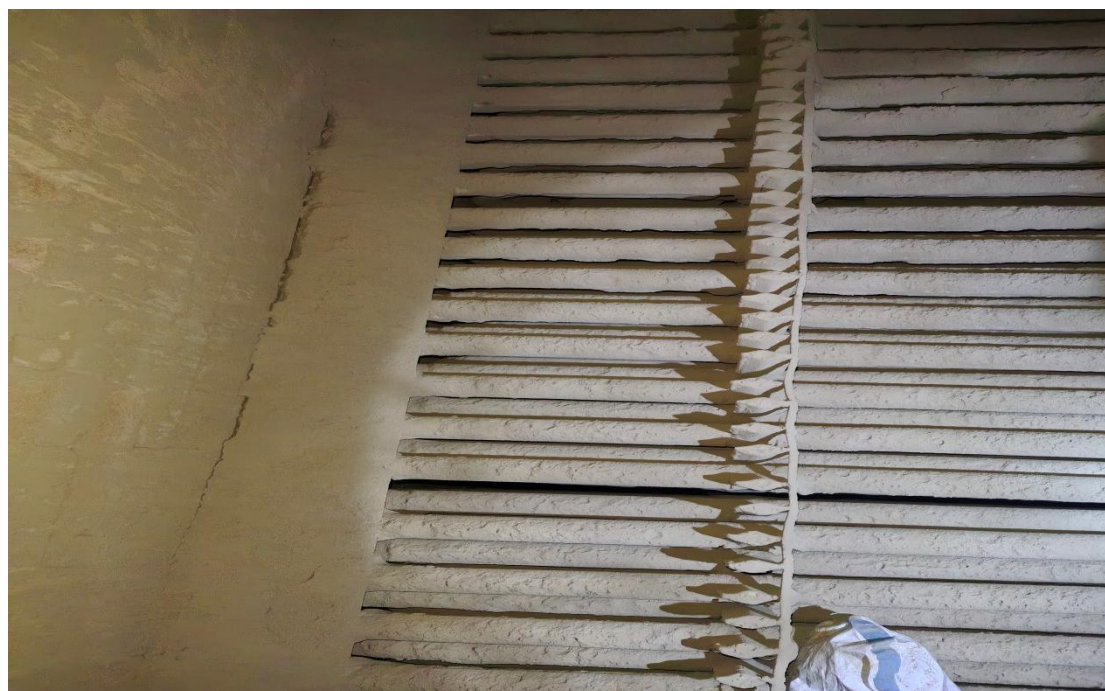
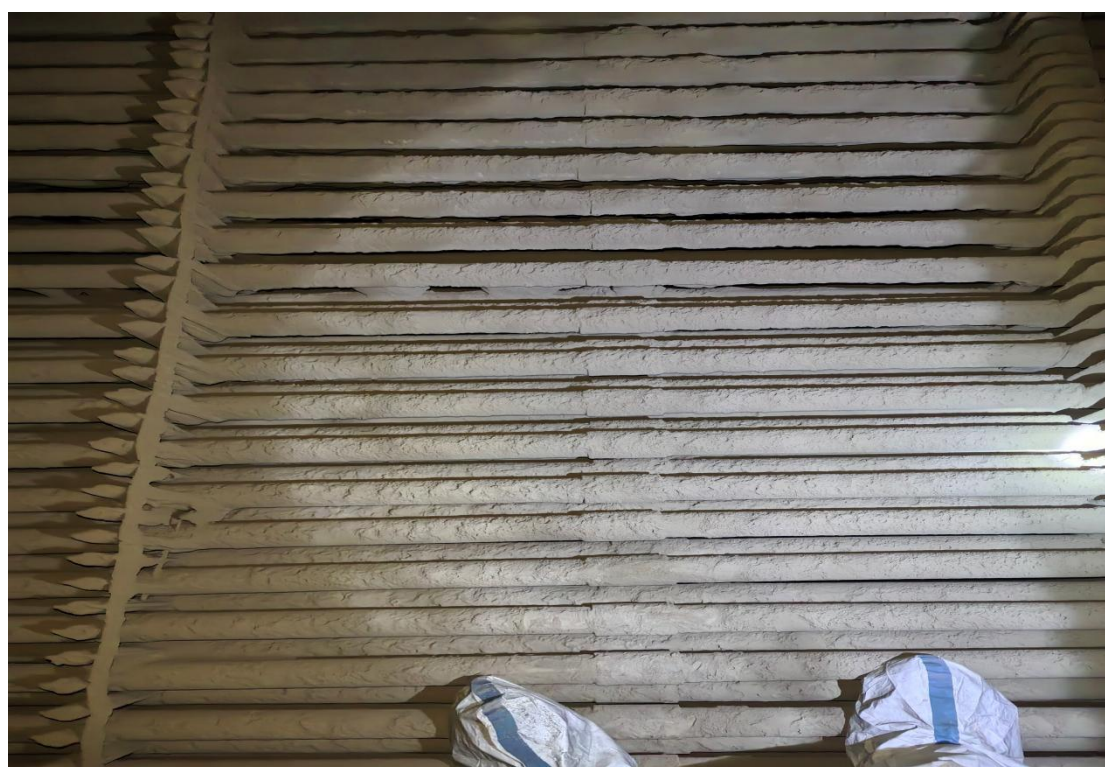
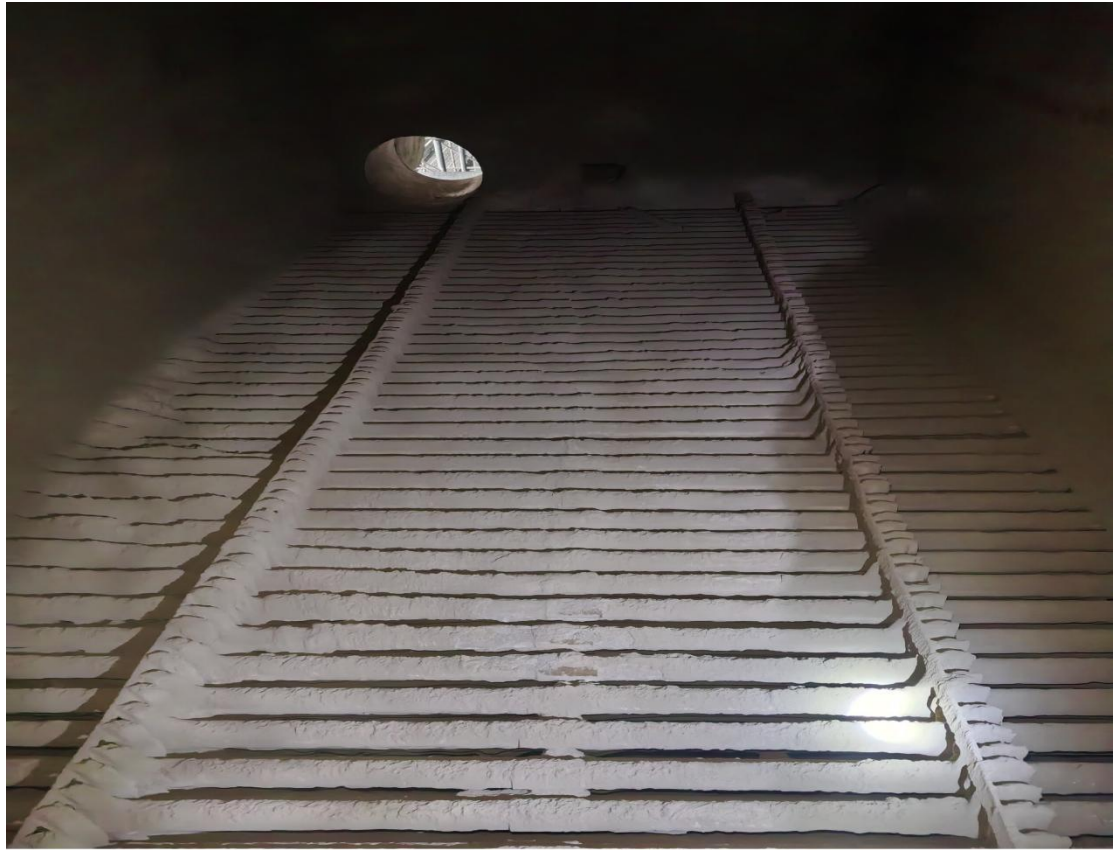
#1 炉：下级省煤器检查管子外壳有完整防磨瓦，管排积有一部分灰，

管排之间有间隙，穿墙管未见异常
