## 陕西神北聚能热力有限公司

### 燃煤锅炉及辅机系统精细化巡检检查报告

我公司组织技术人员于 2026 年 7 月 13 日-2026 年 7 月 20 日对贵公司两台 46MW 流化床供热锅炉进行系统精细化巡检，检查发现以下问题：

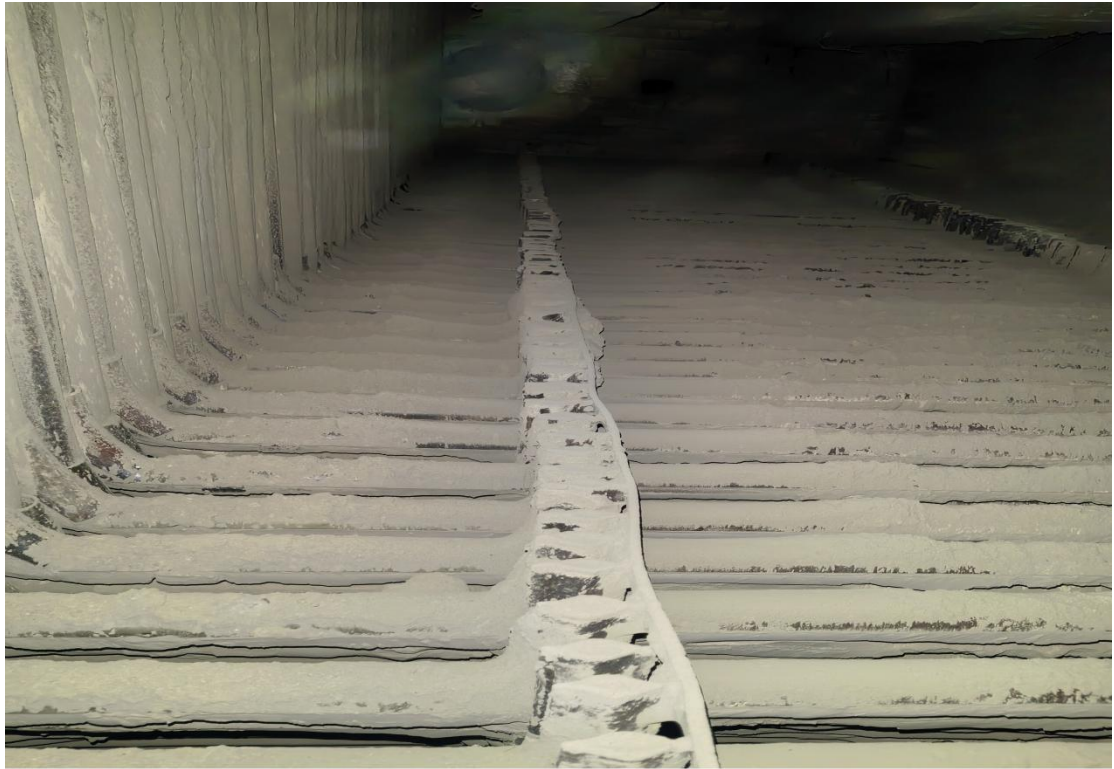
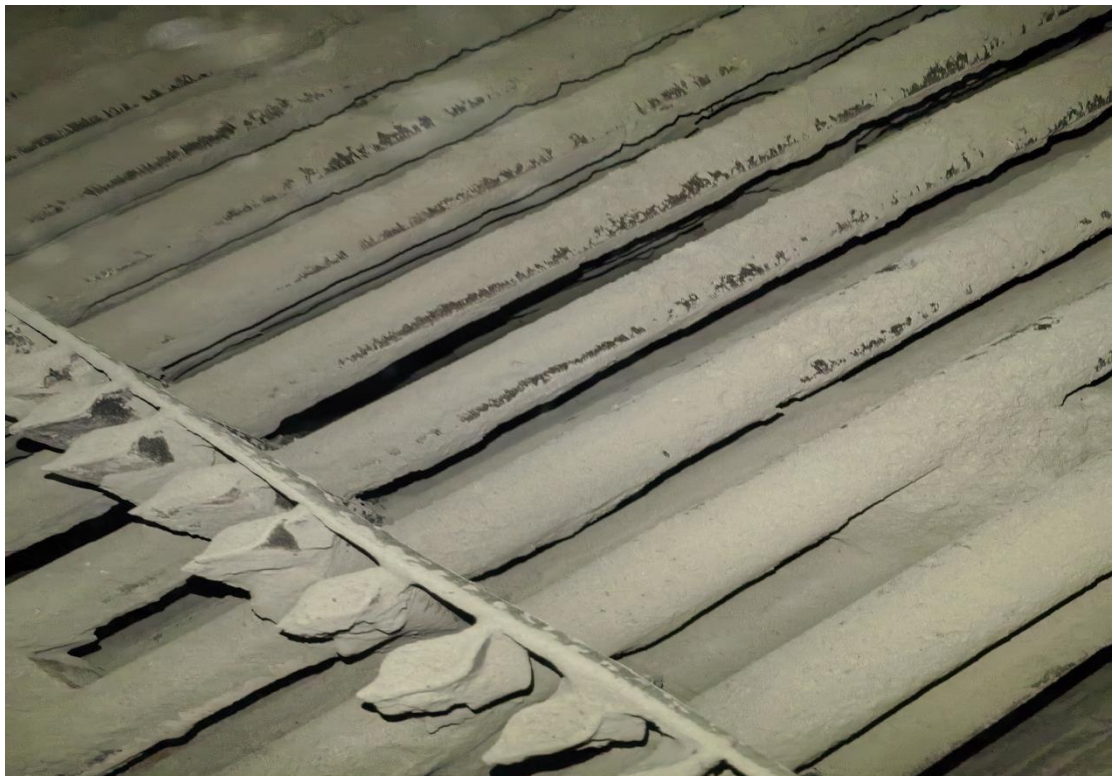
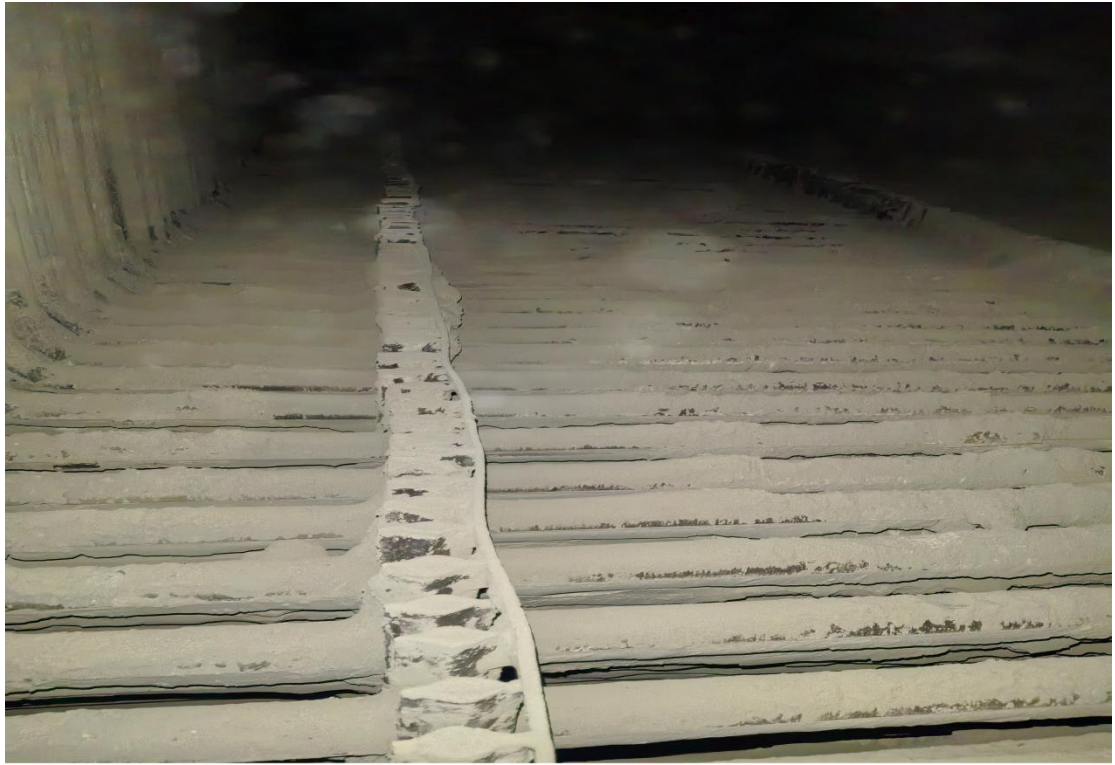
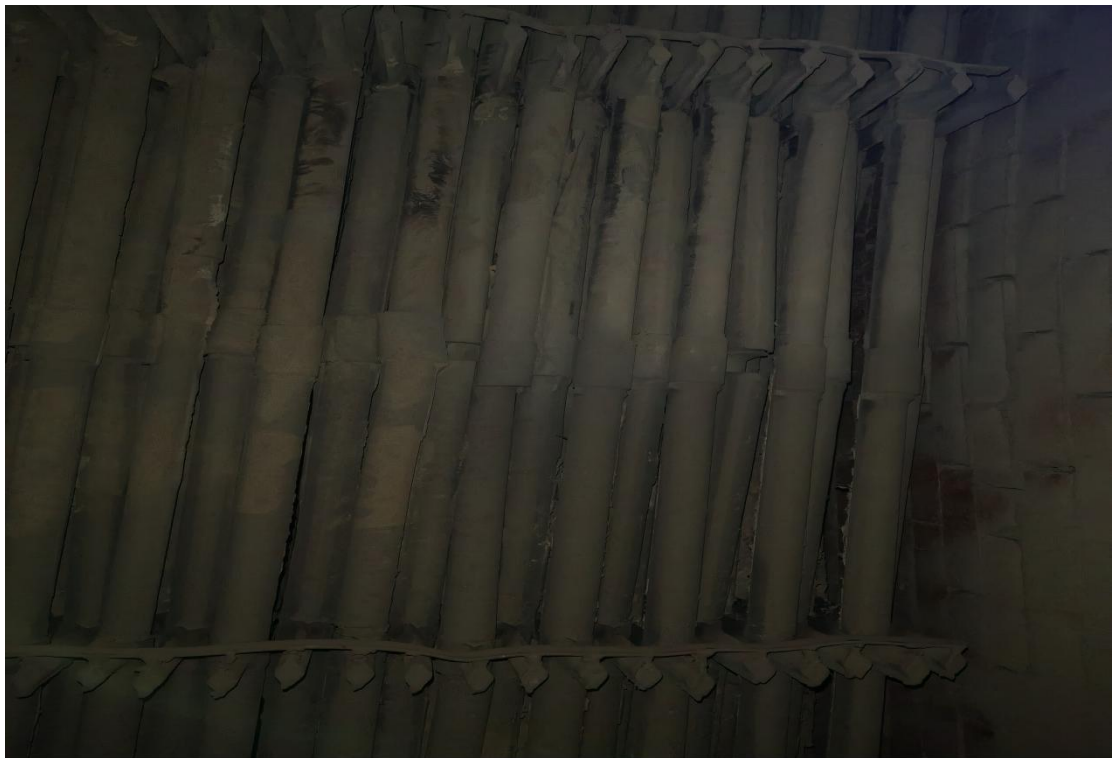
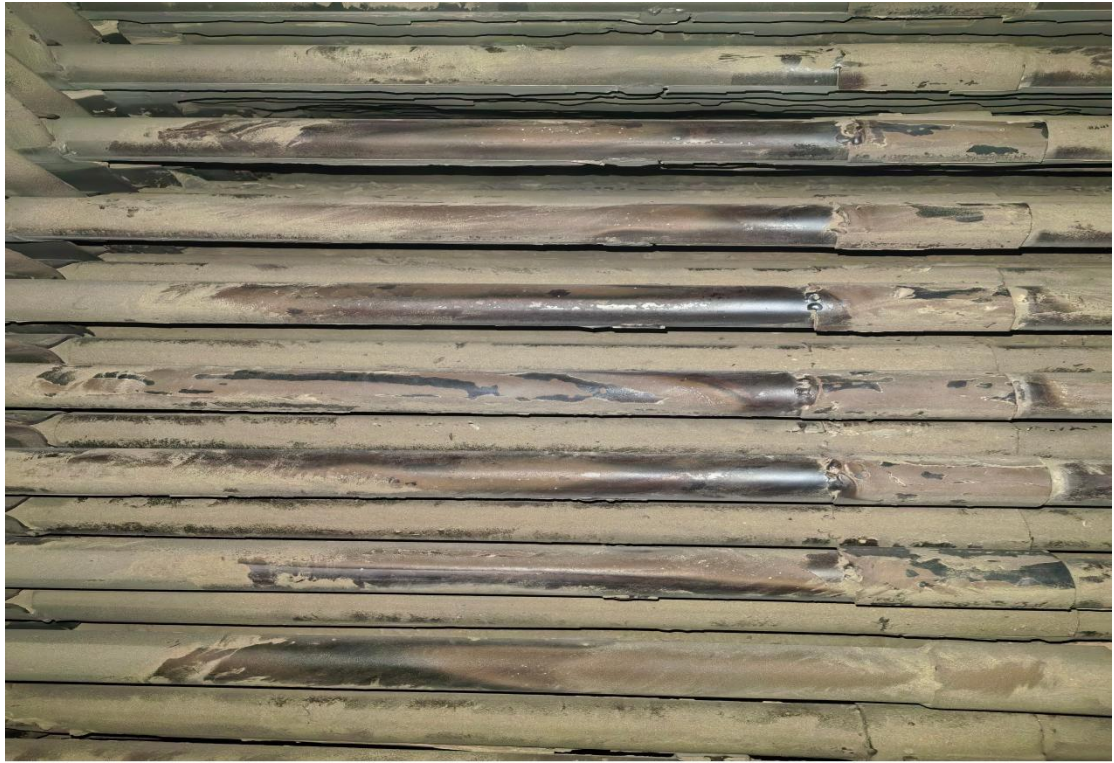
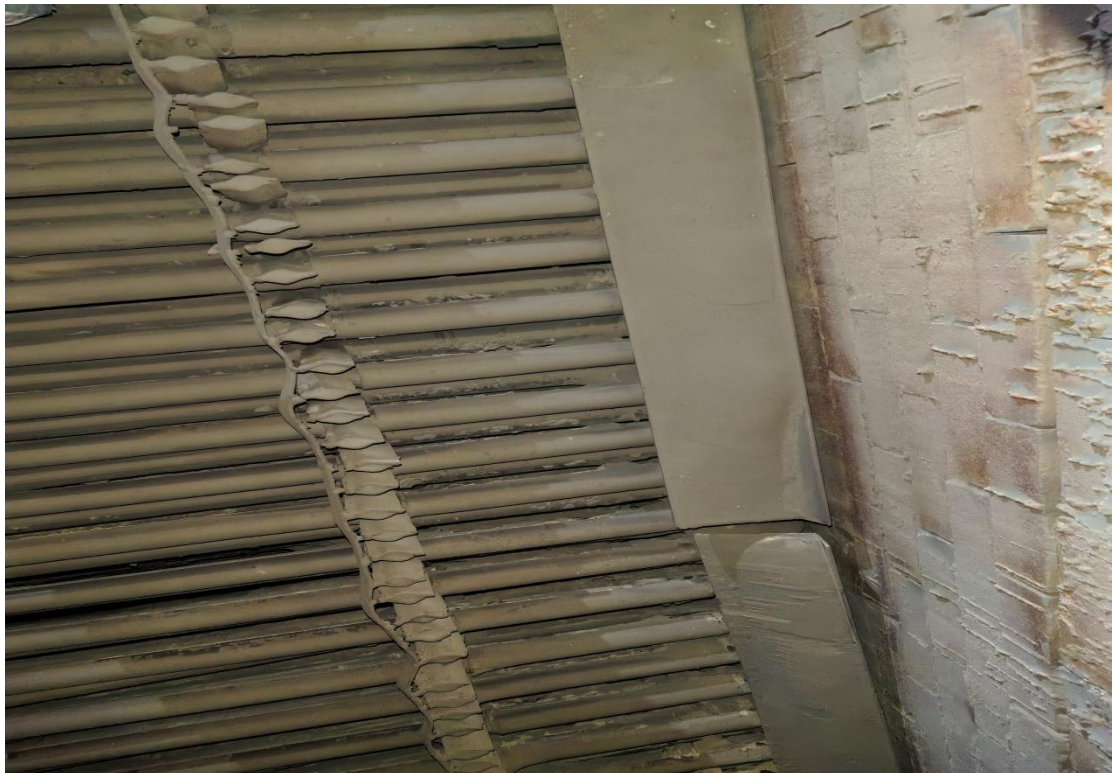
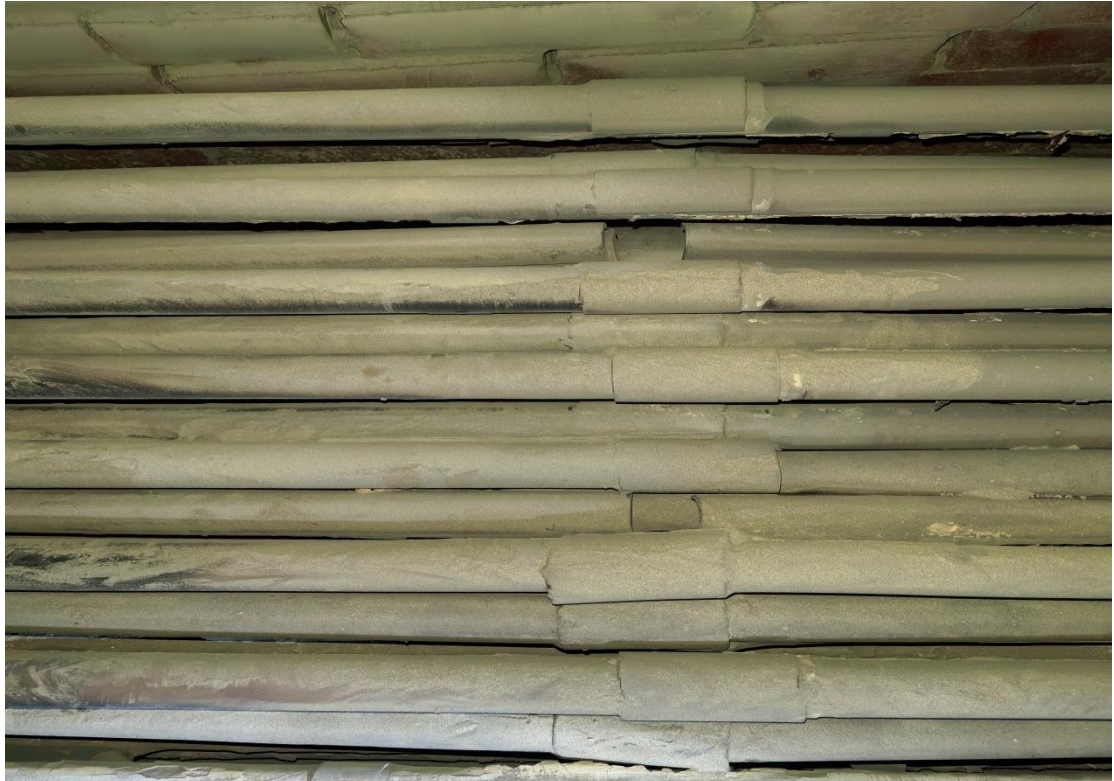
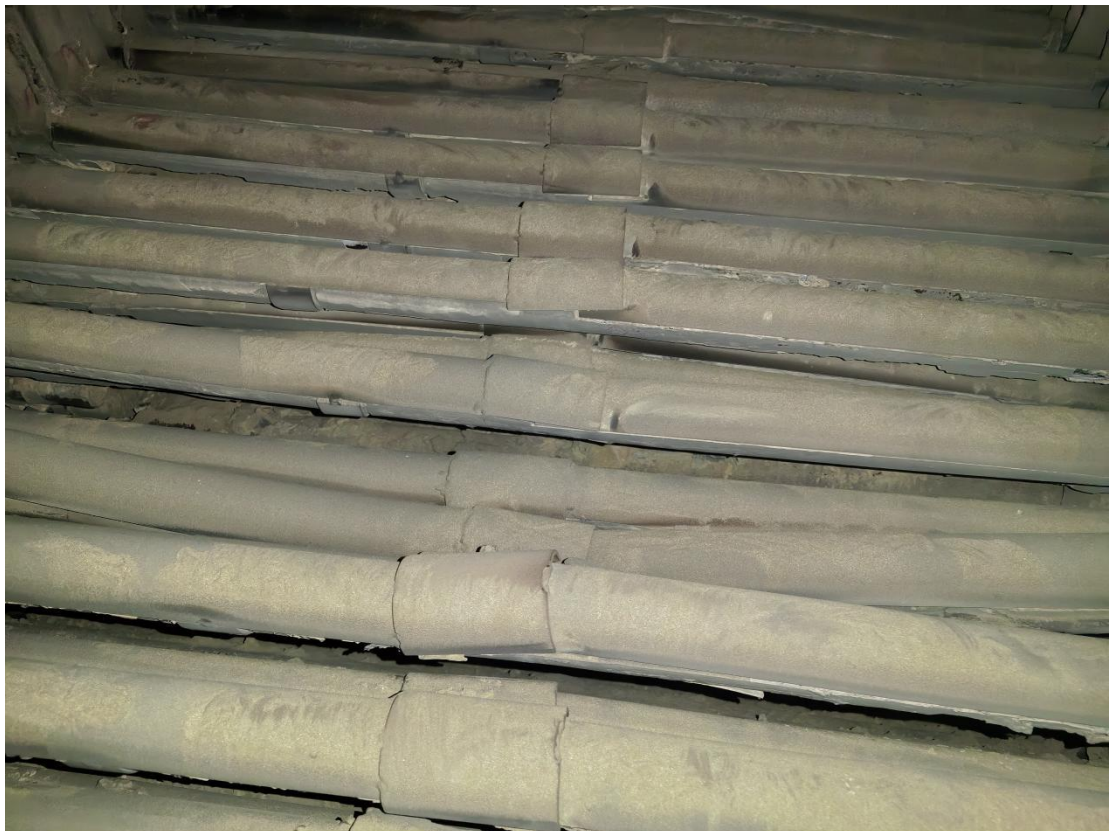
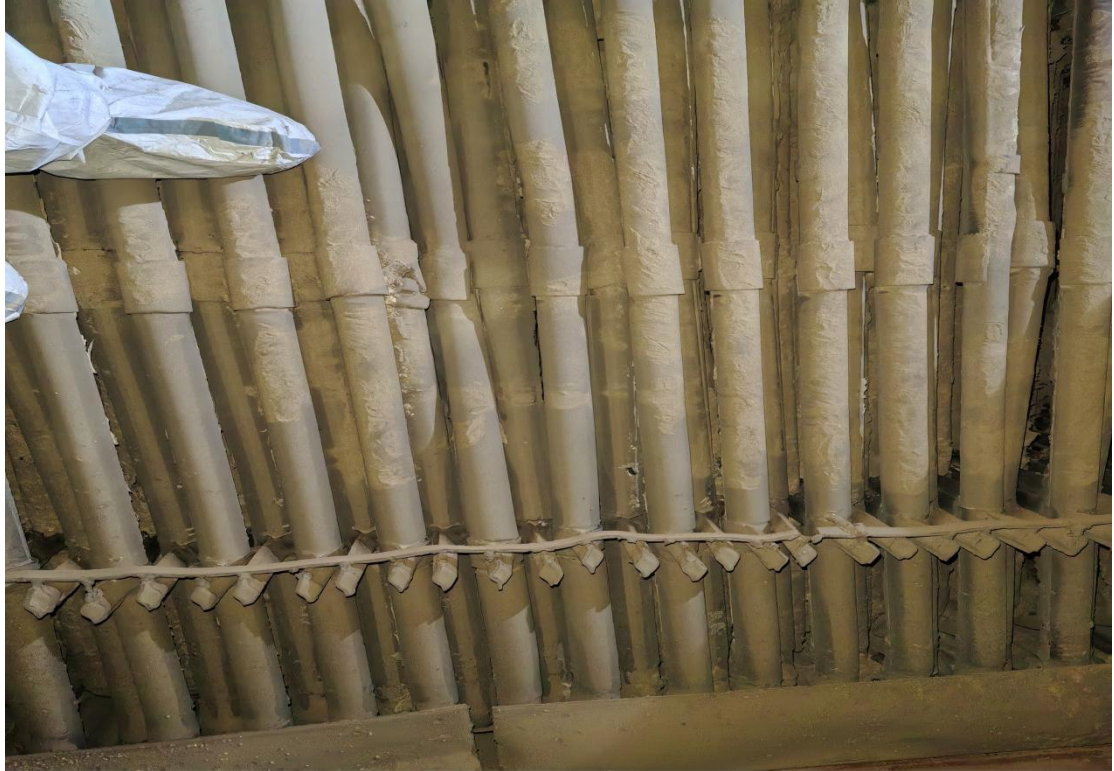
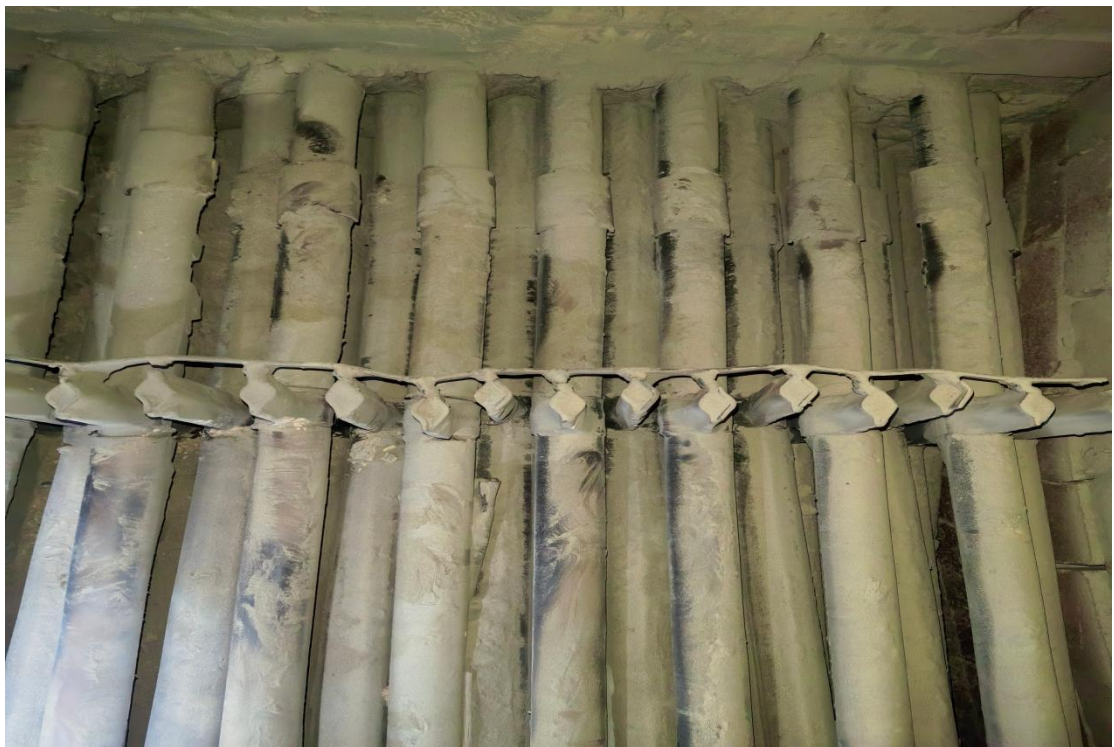
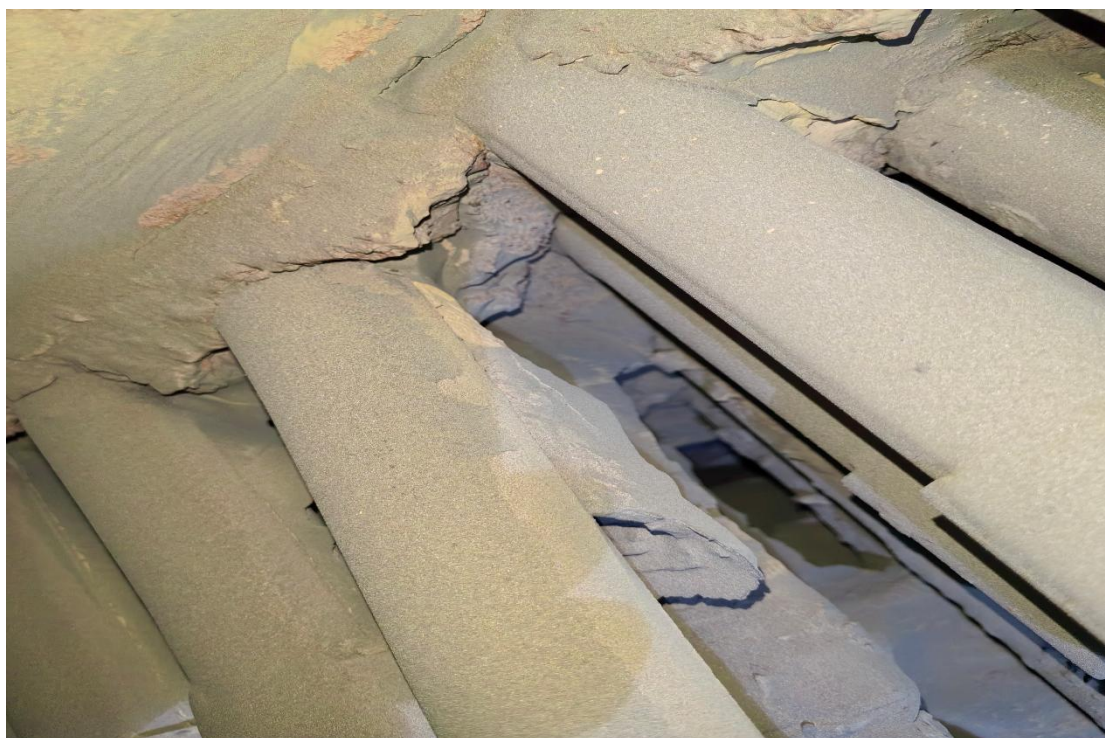
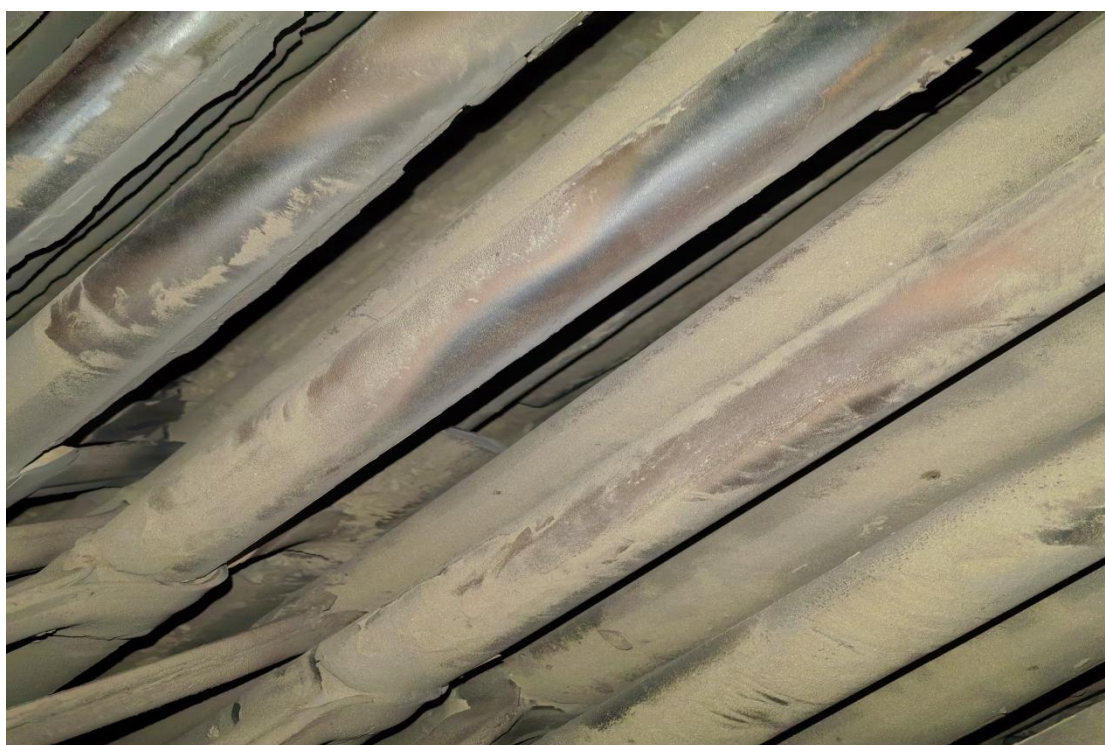
中层省煤器检查外壳有完整防磨瓦，管排积有一部分灰，管排之间有间隙，穿墙管未见异常

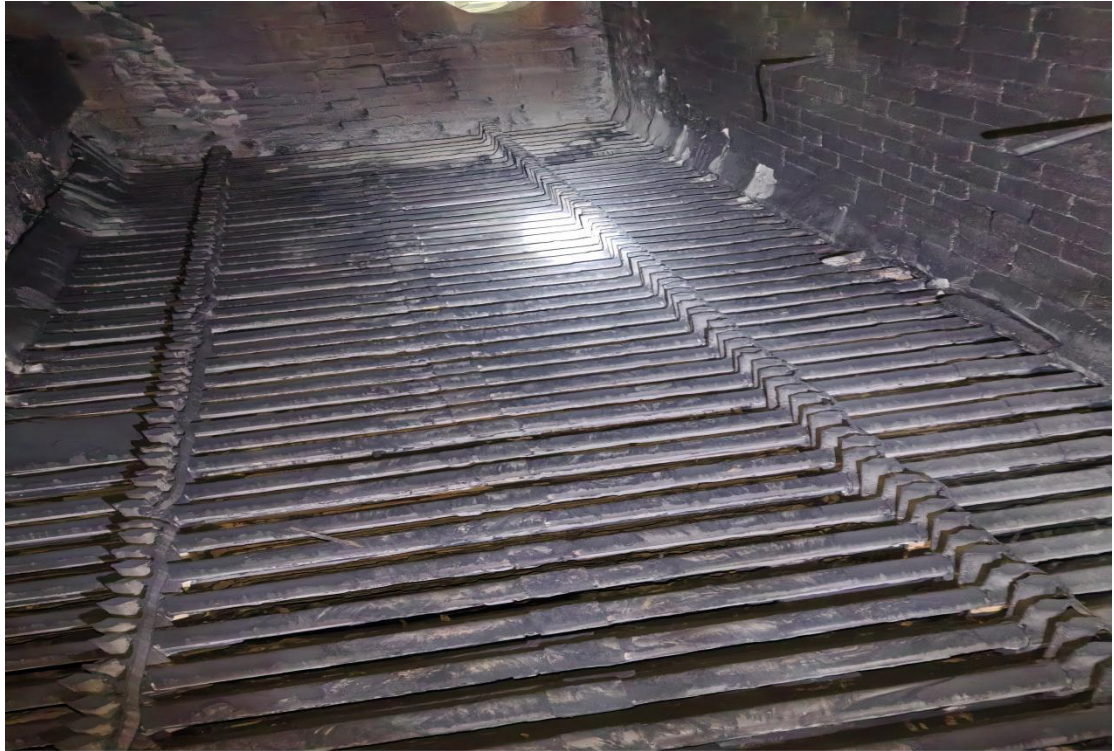
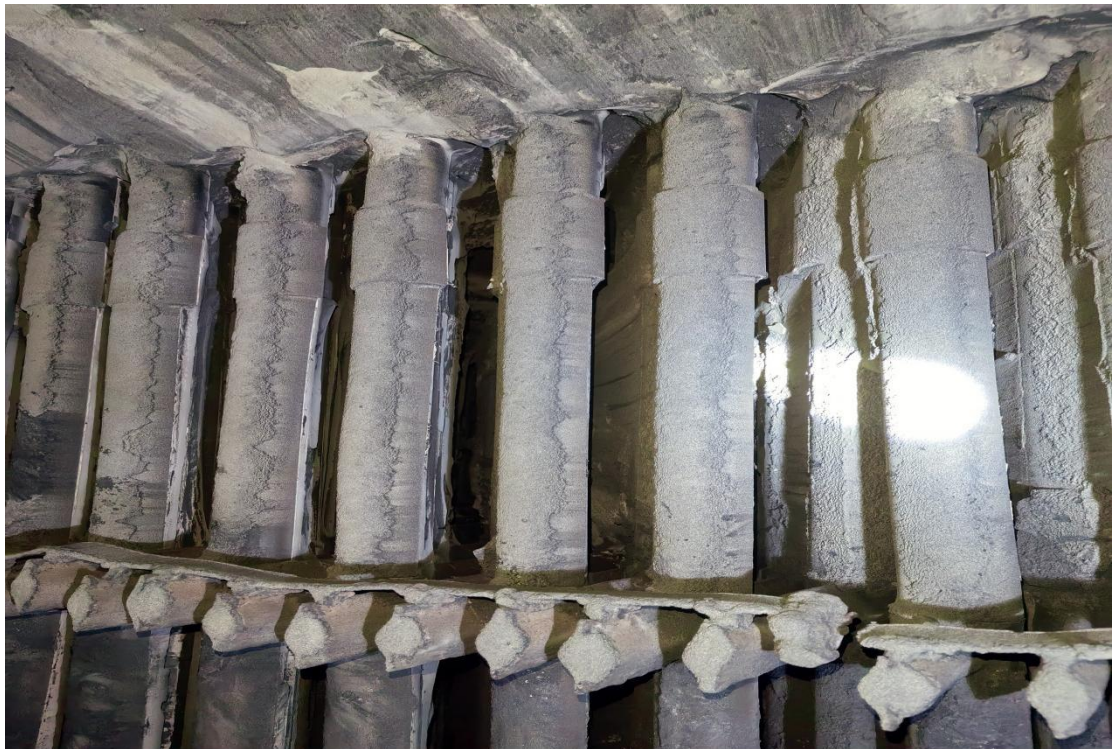
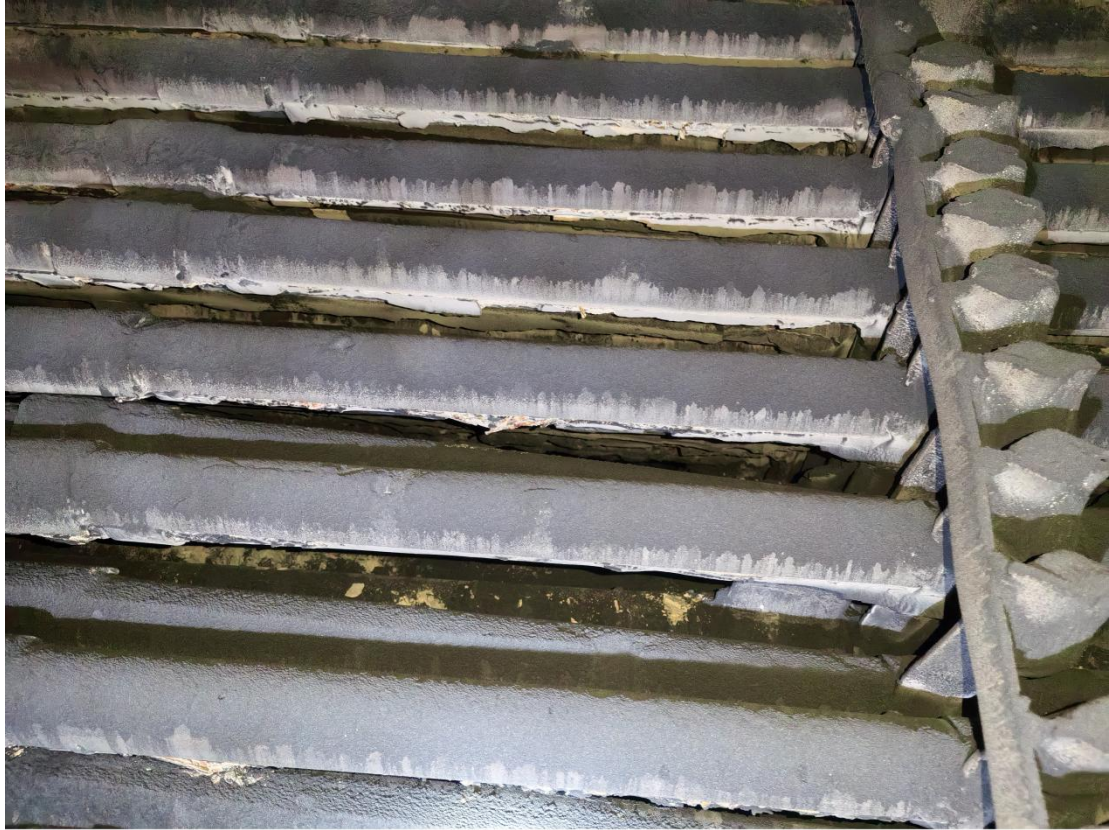
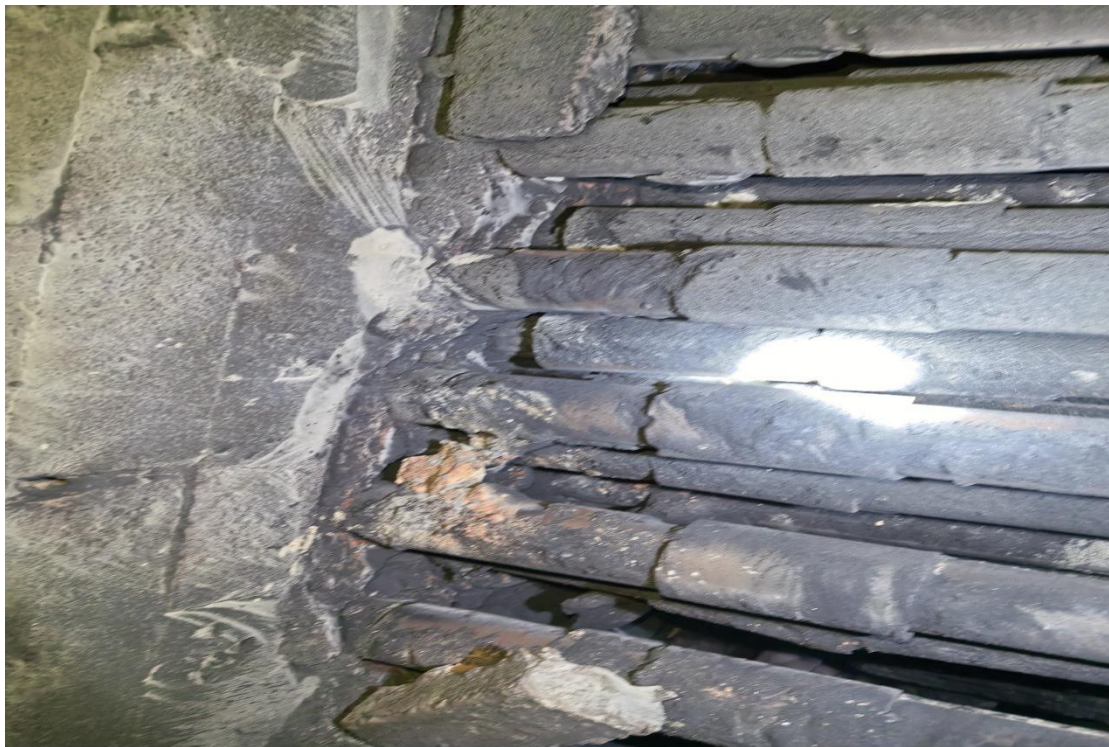
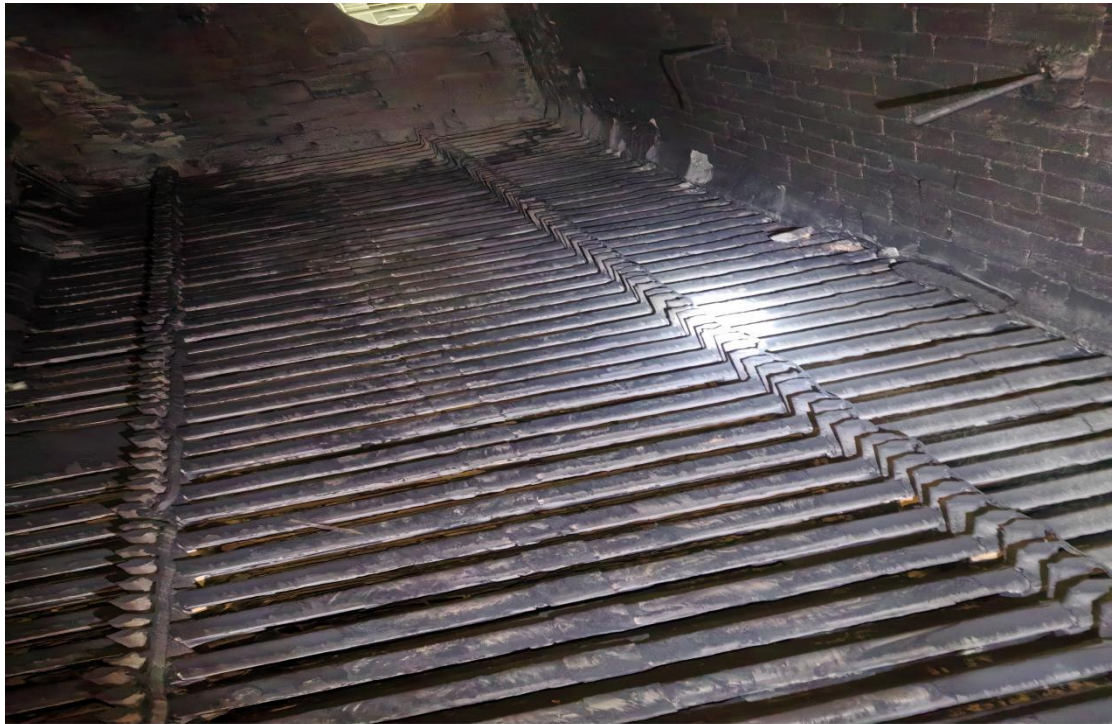
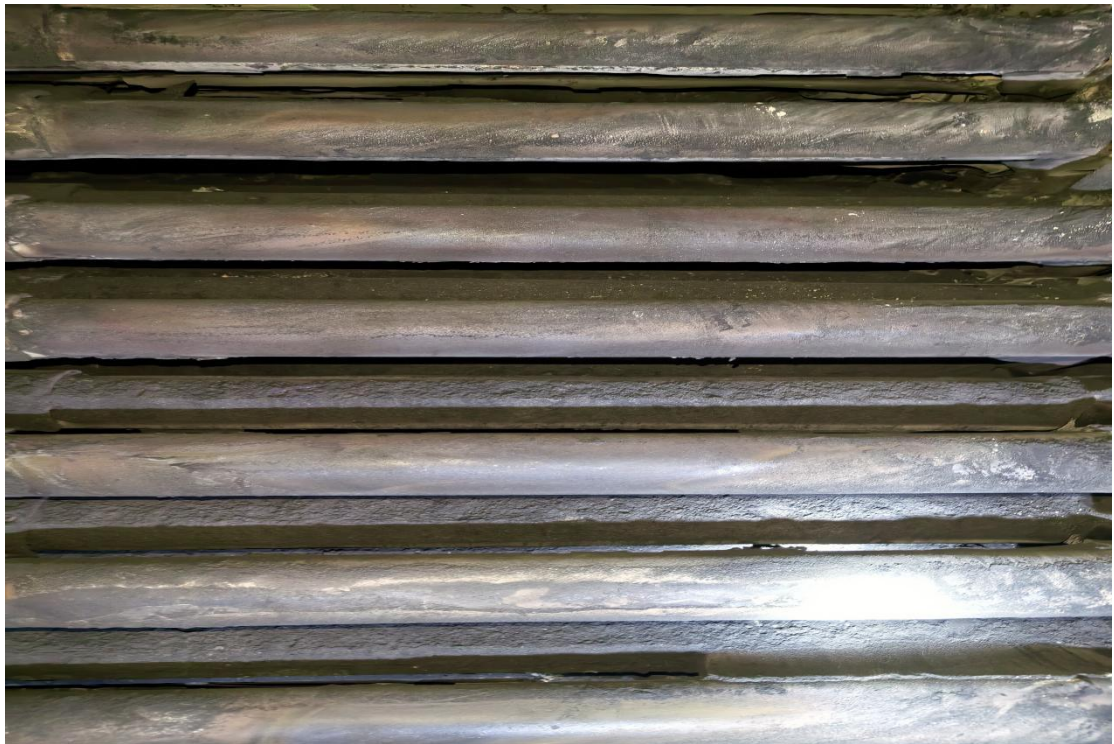
#2 炉省煤器：上层检查有部分积灰，管排之间有间隙，防磨瓦完整  
未见明显缺陷

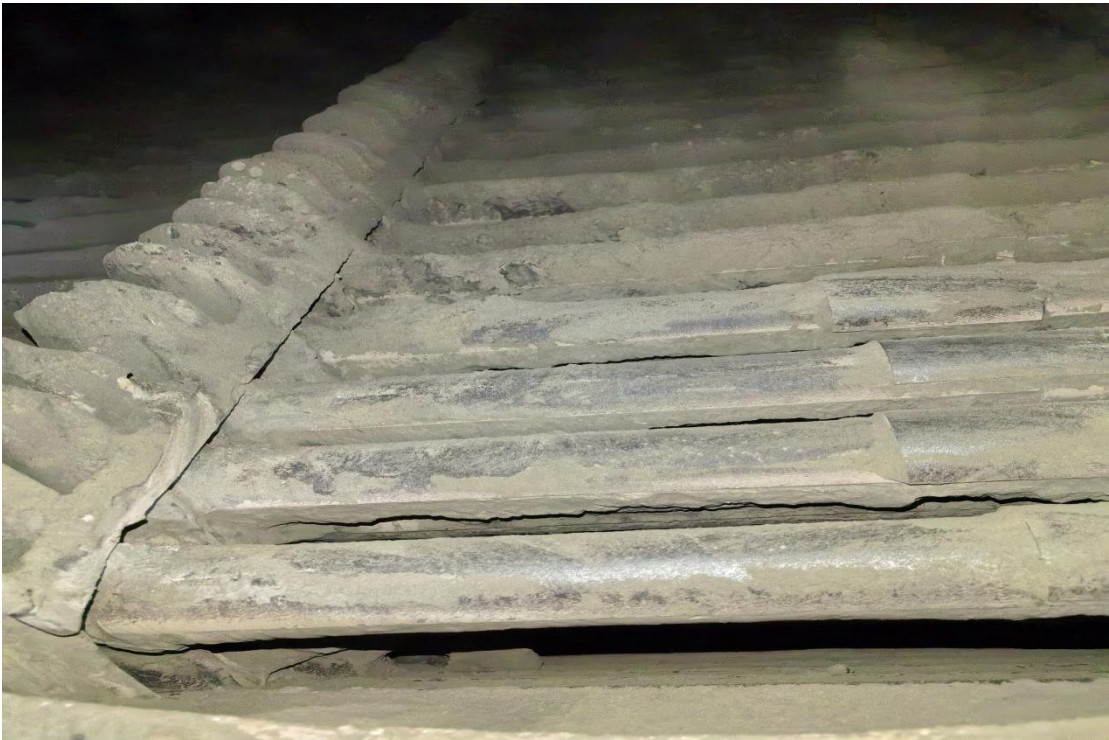
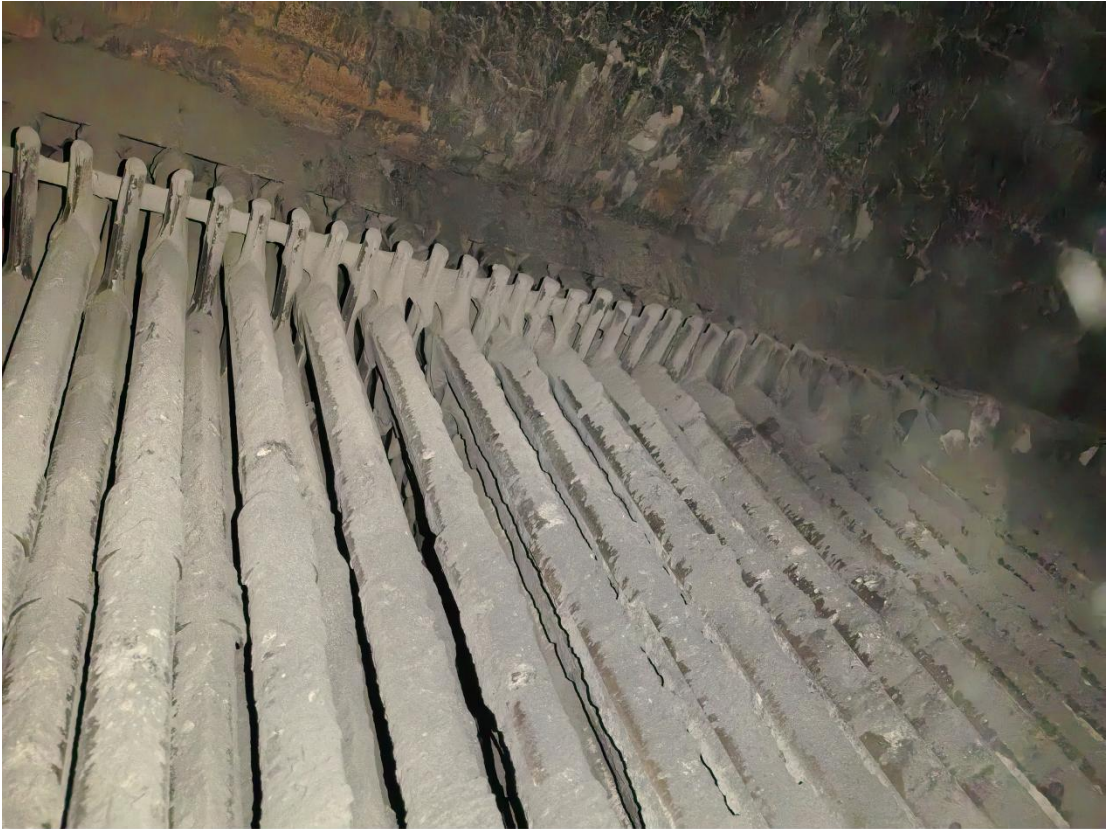
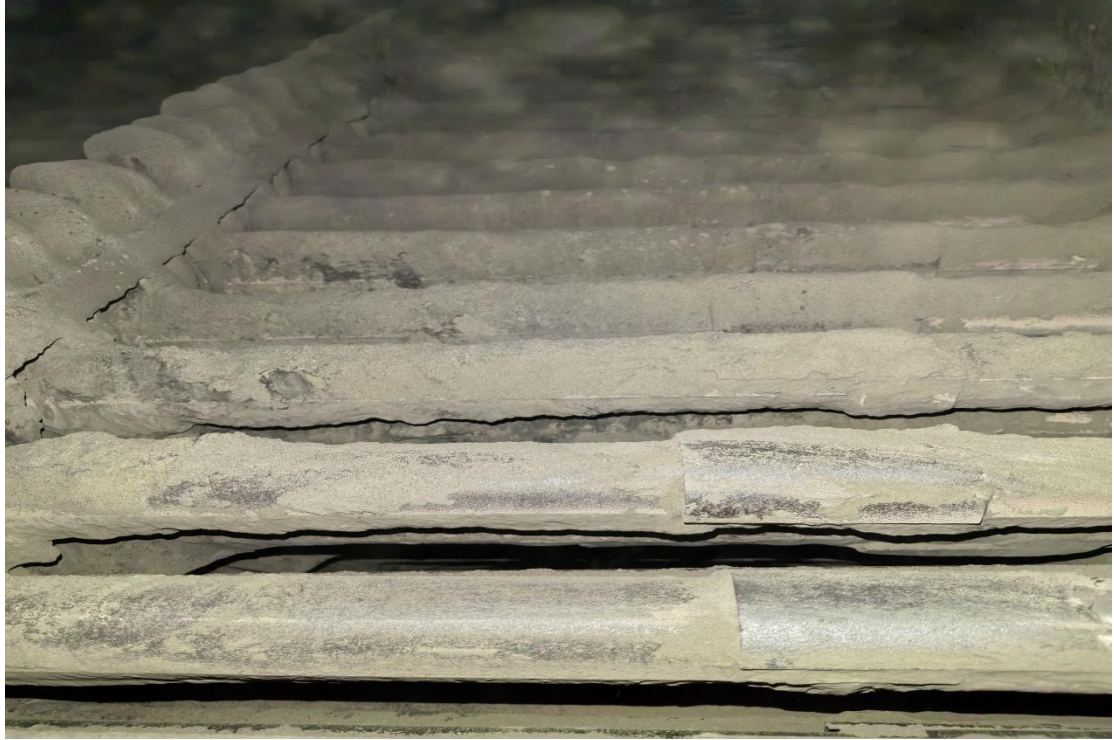
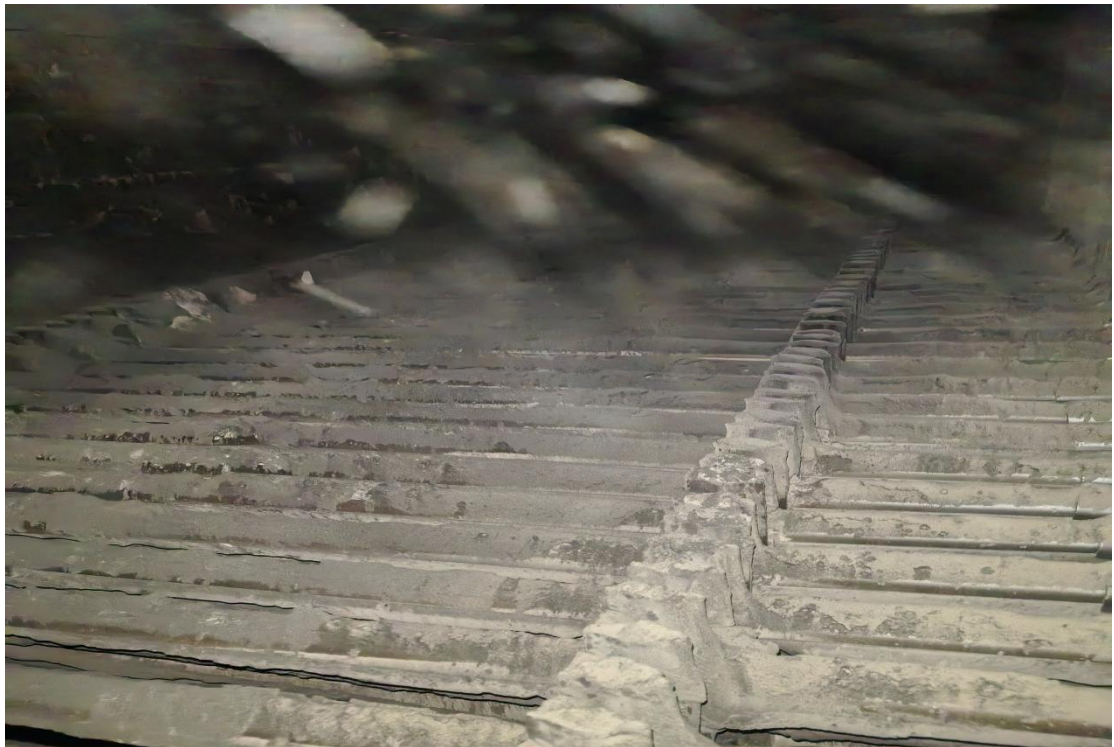
中层及下层省煤器检查积灰一般，防磨瓦完整，管排之间有间隙

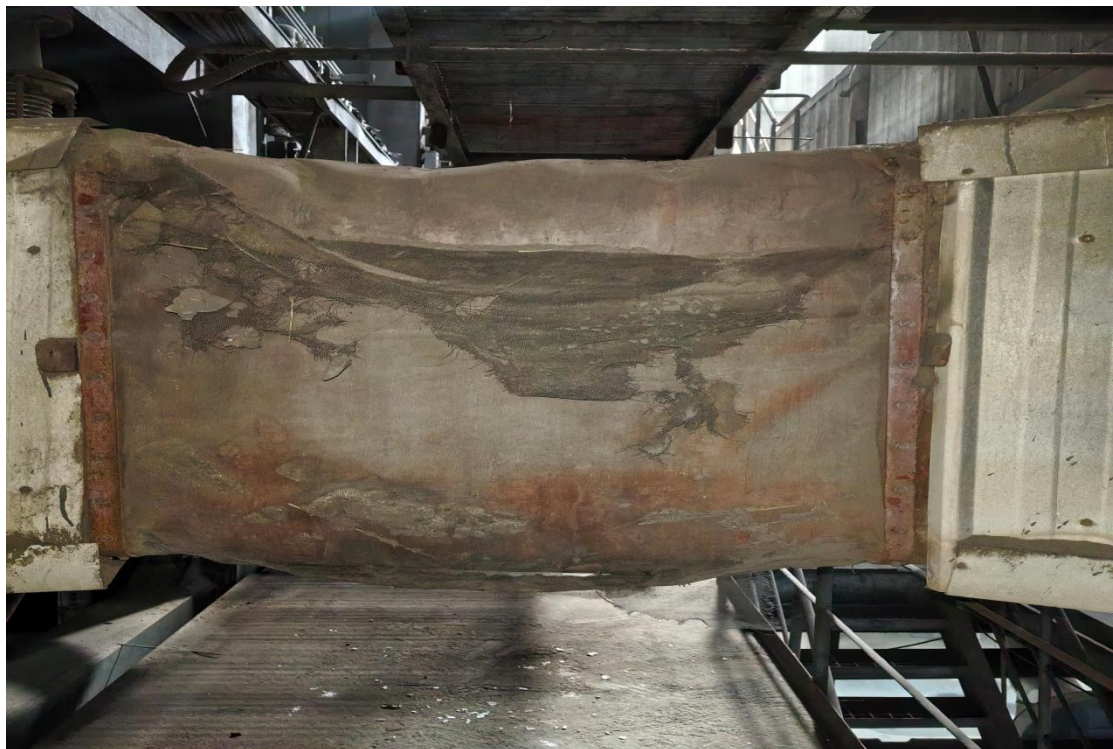
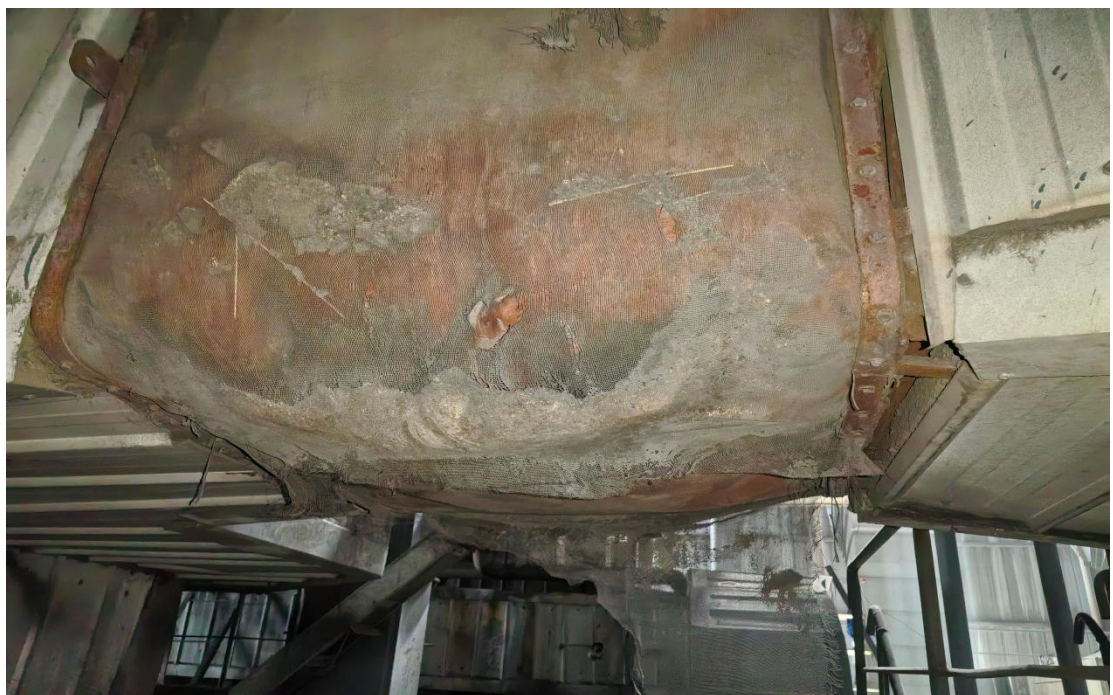
#### 四、风道膨胀节检查：#1 锅炉：软连接处有鼓包破损现象

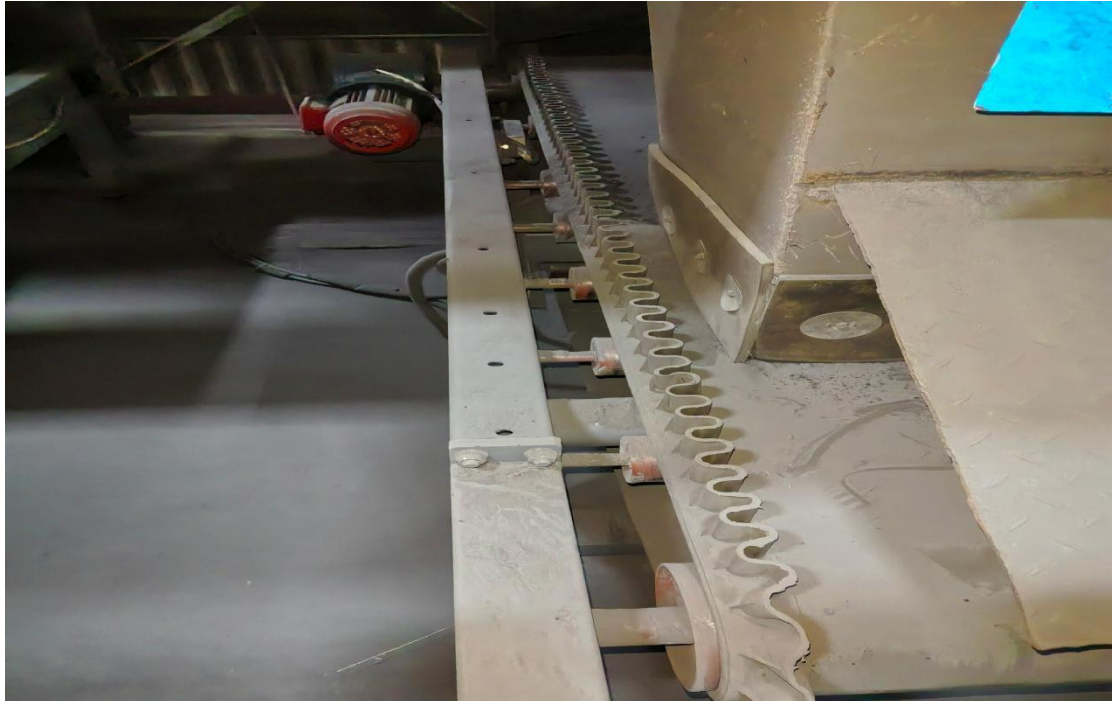
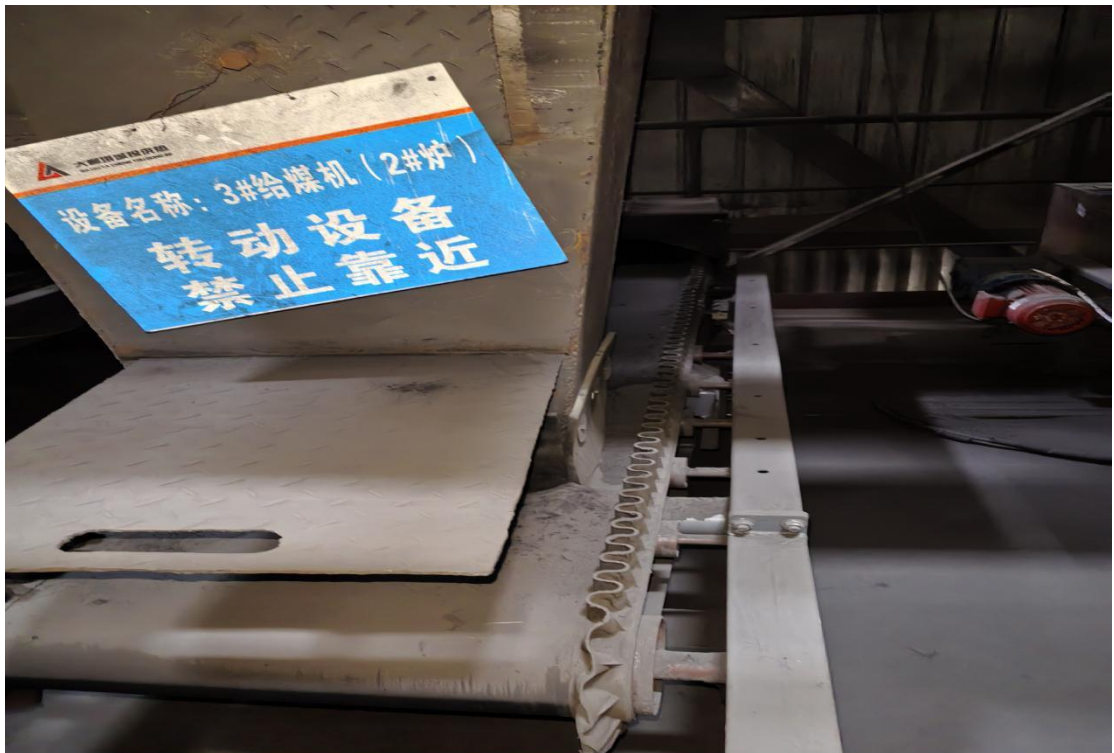
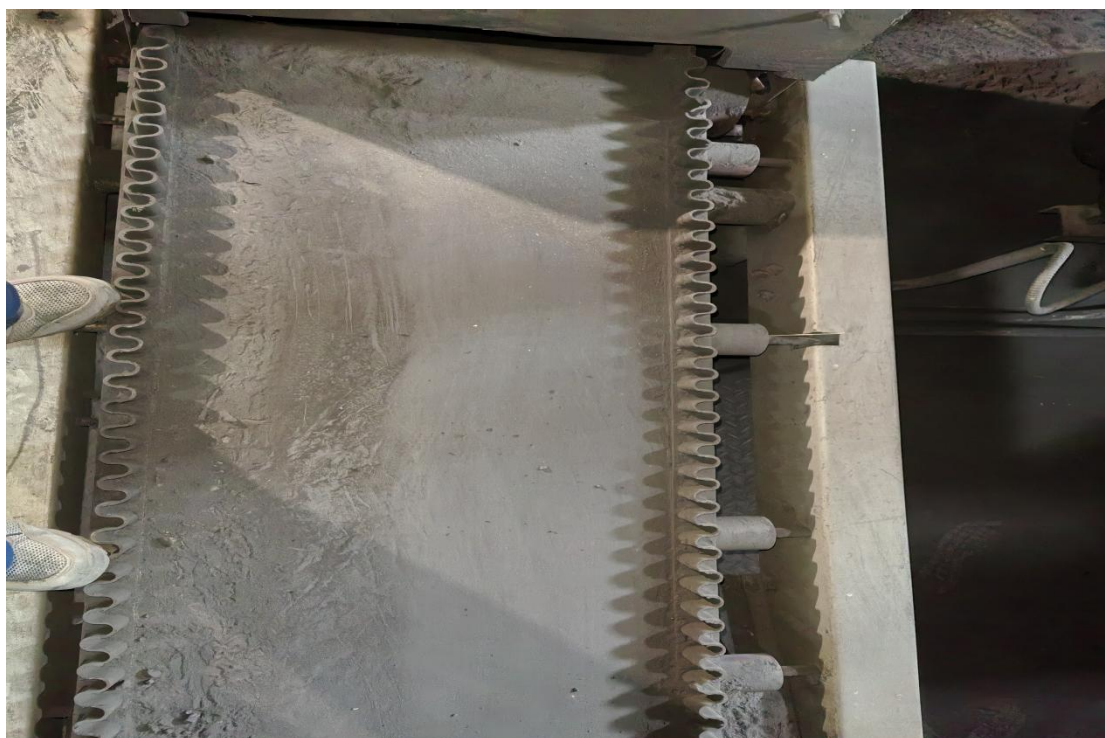
#### 五、给煤机：检查发现皮带有一定跑偏现象，托辊良好
