## 陕西神北聚能热力有限公司

### 燃煤锅炉及辅机系统精细化巡检检查报告

我公司组织技术人员于 2026 年 7 月 13 日-2026 年 7 月 20 日对贵公司两台 46MW 流化床供热锅炉进行系统精细化巡检，检查发现以下问题：

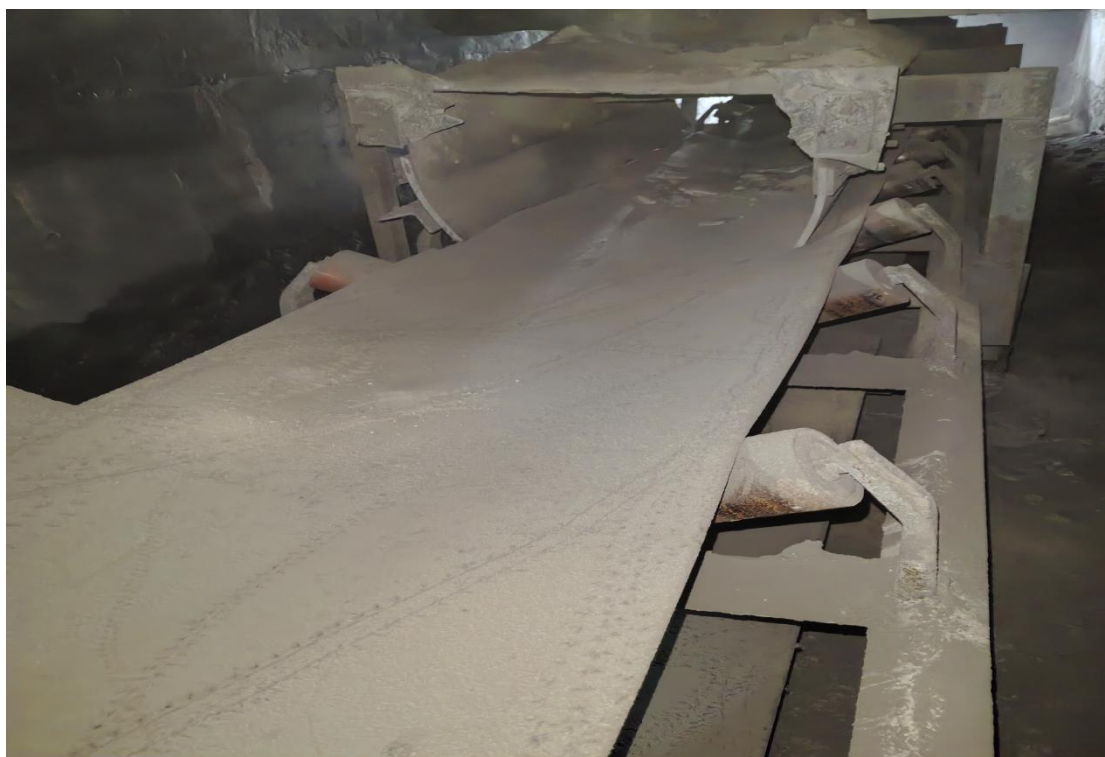
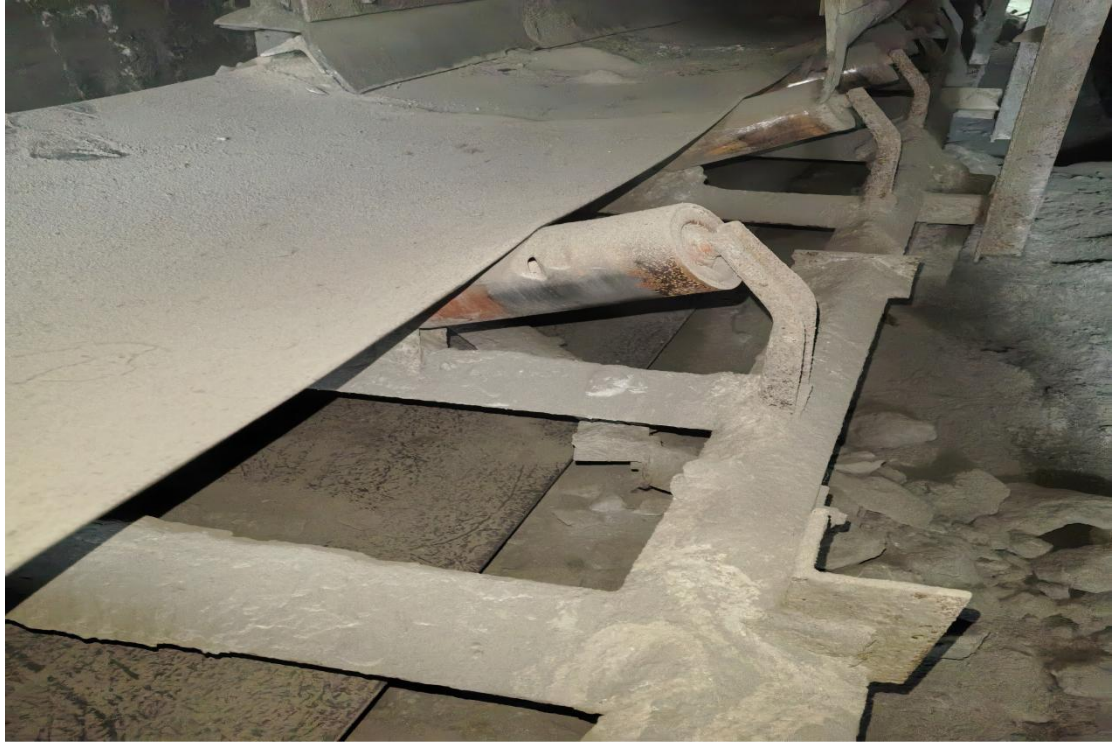
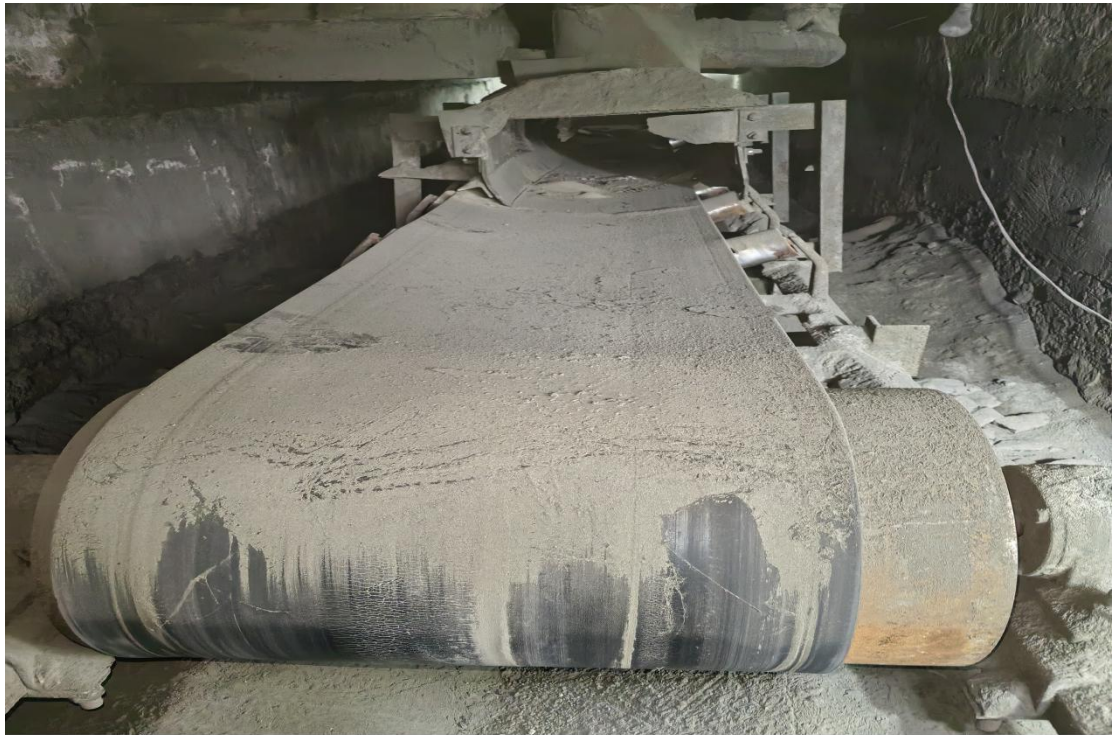
六、出渣系统皮带检查，皮带有轻微跑偏，托辊有个别破损

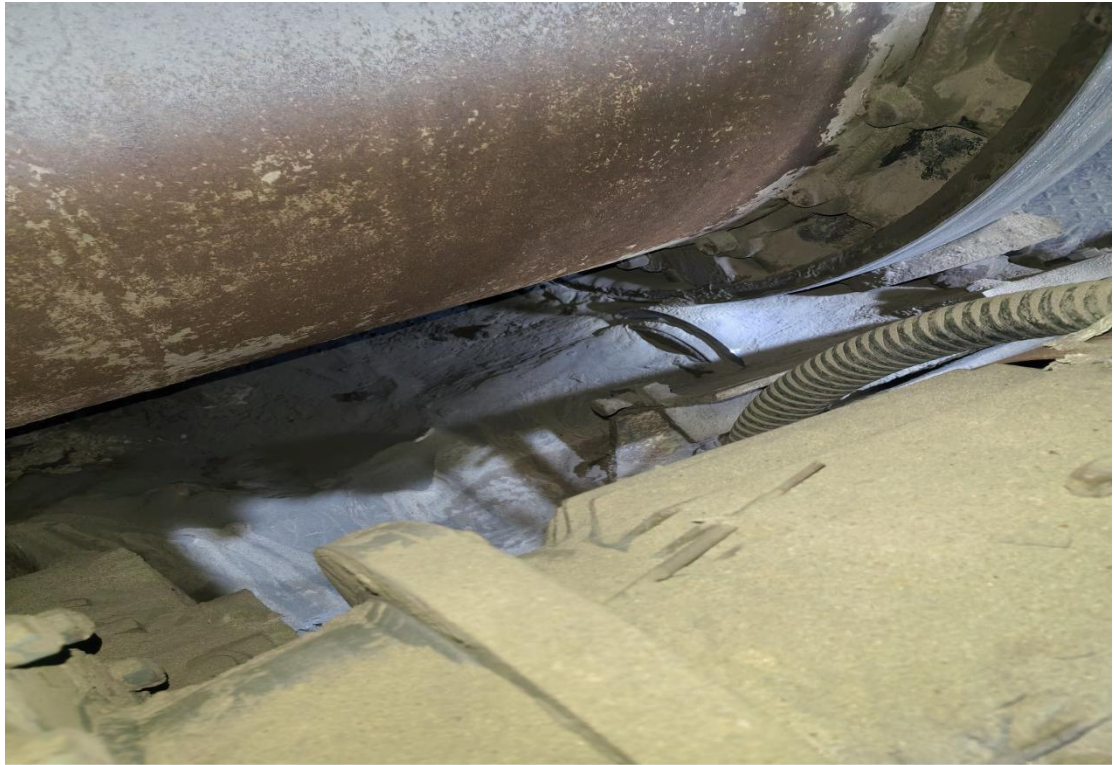
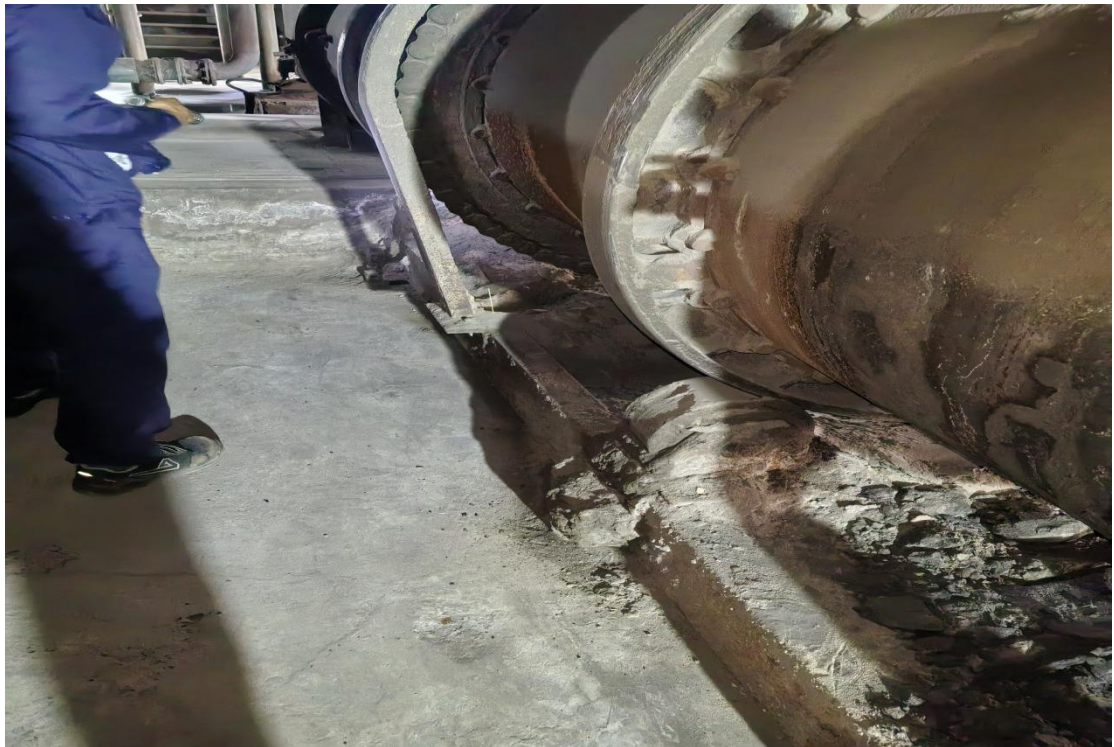
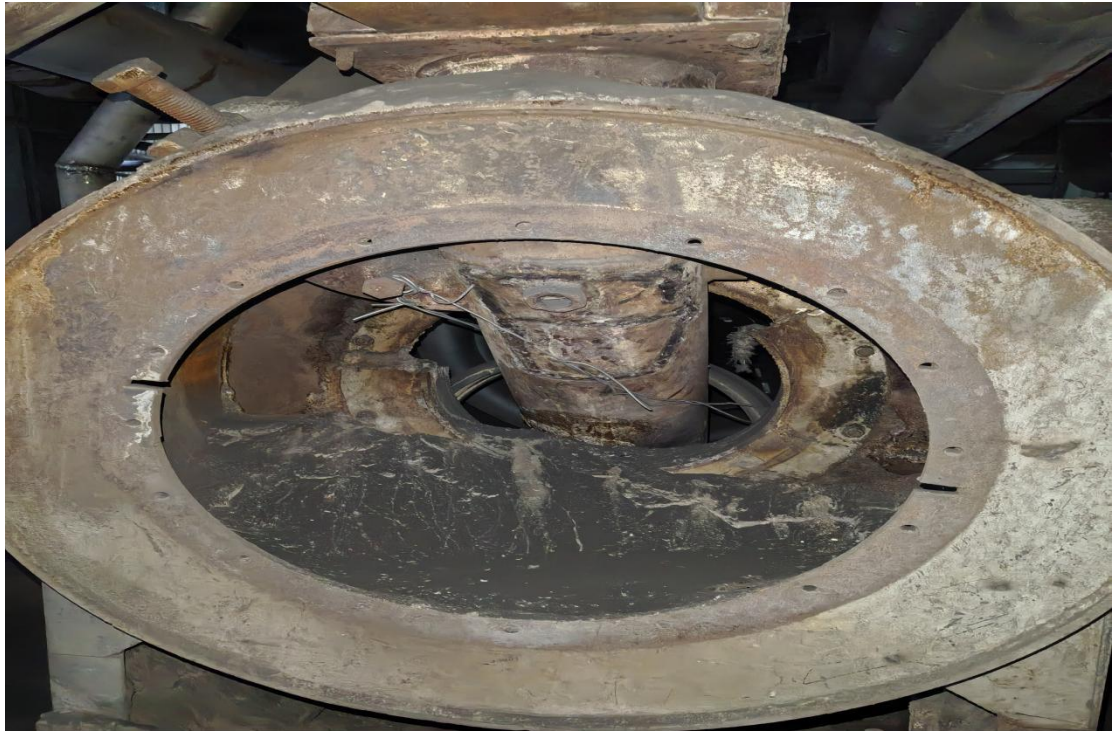
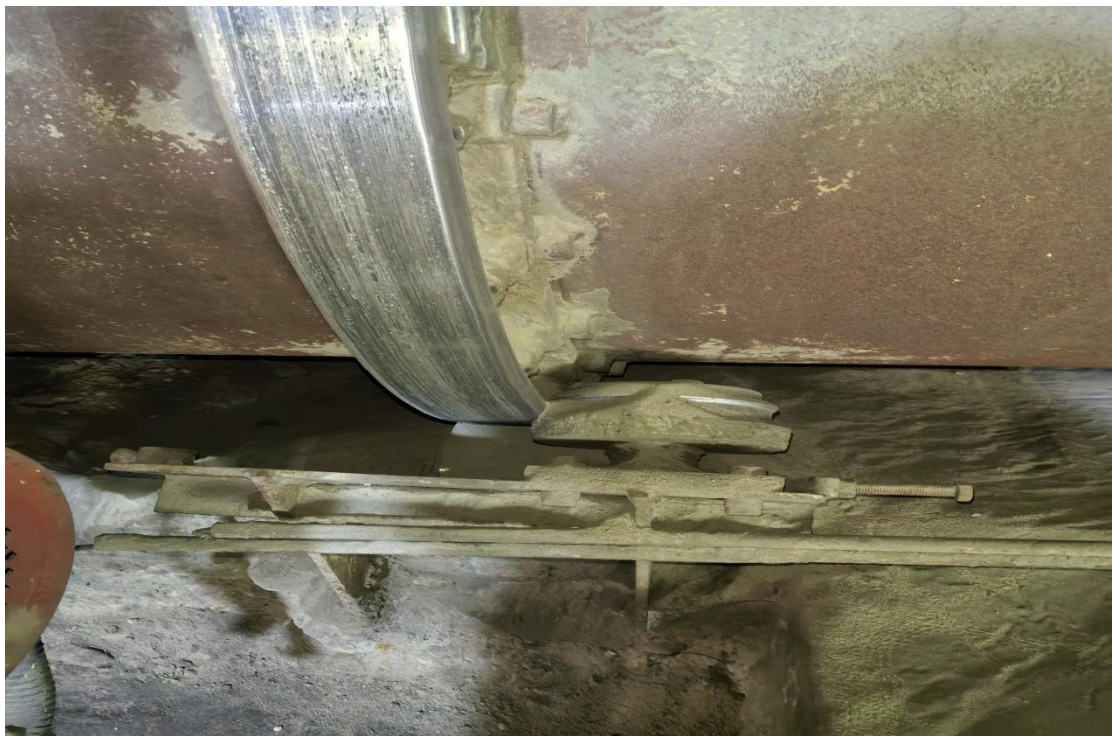
冷渣器滚筒托辊磨损严重, 旋转盘掉落, 冷却水系统漏水严重

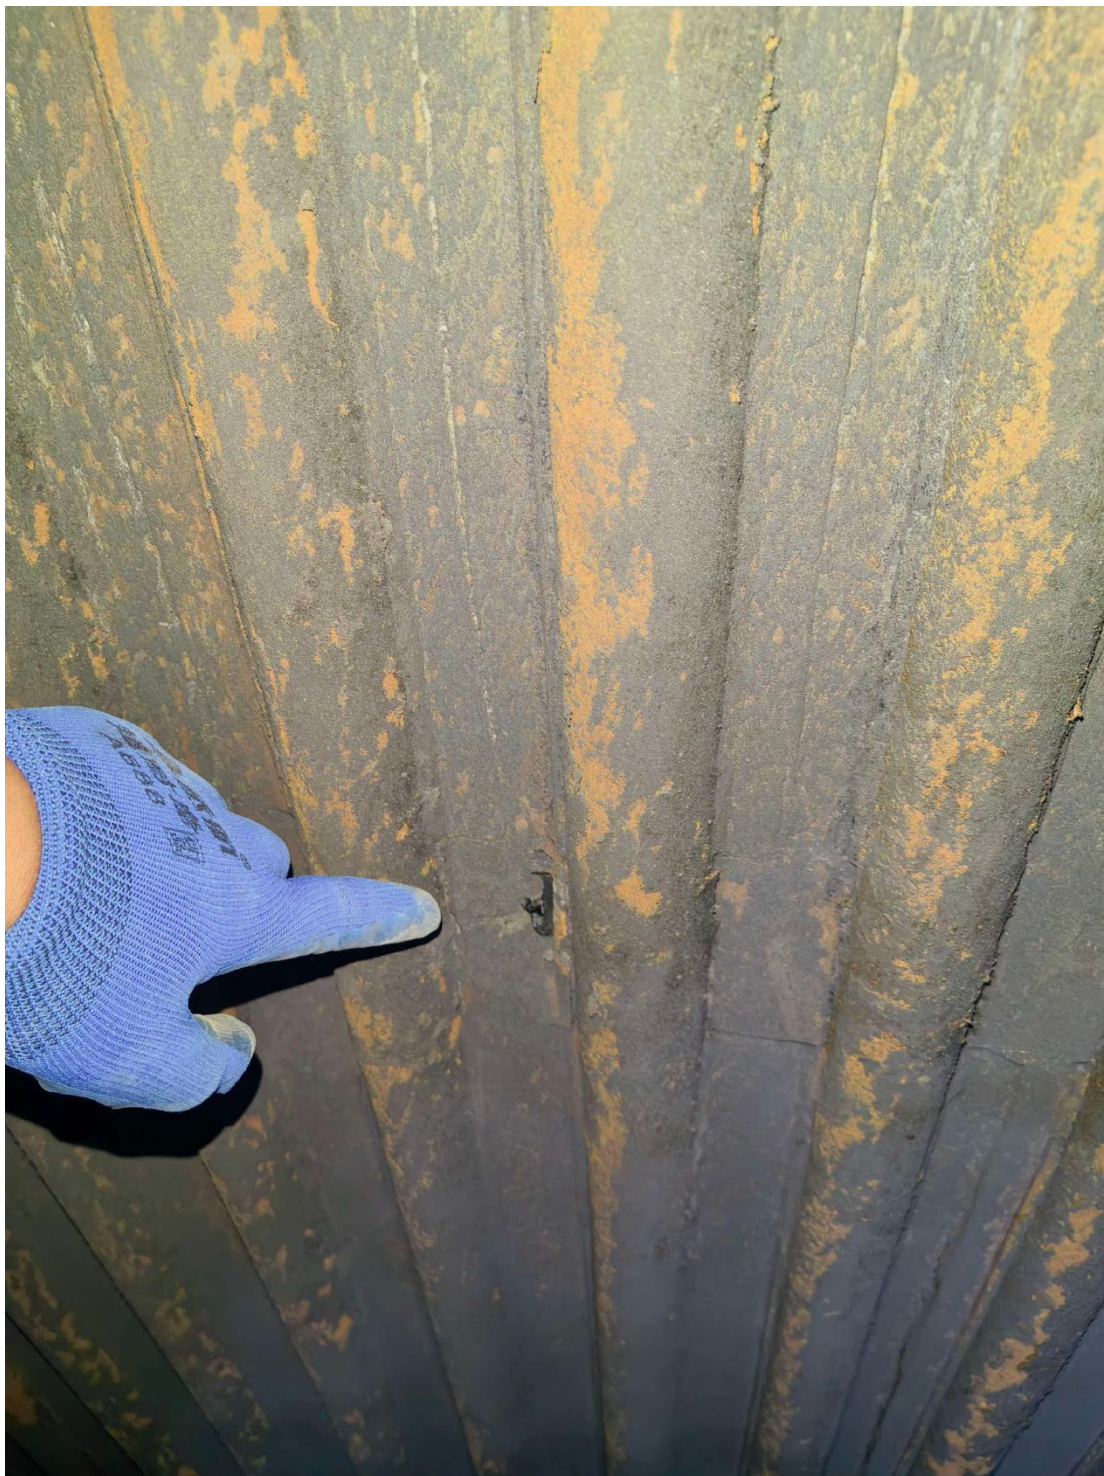
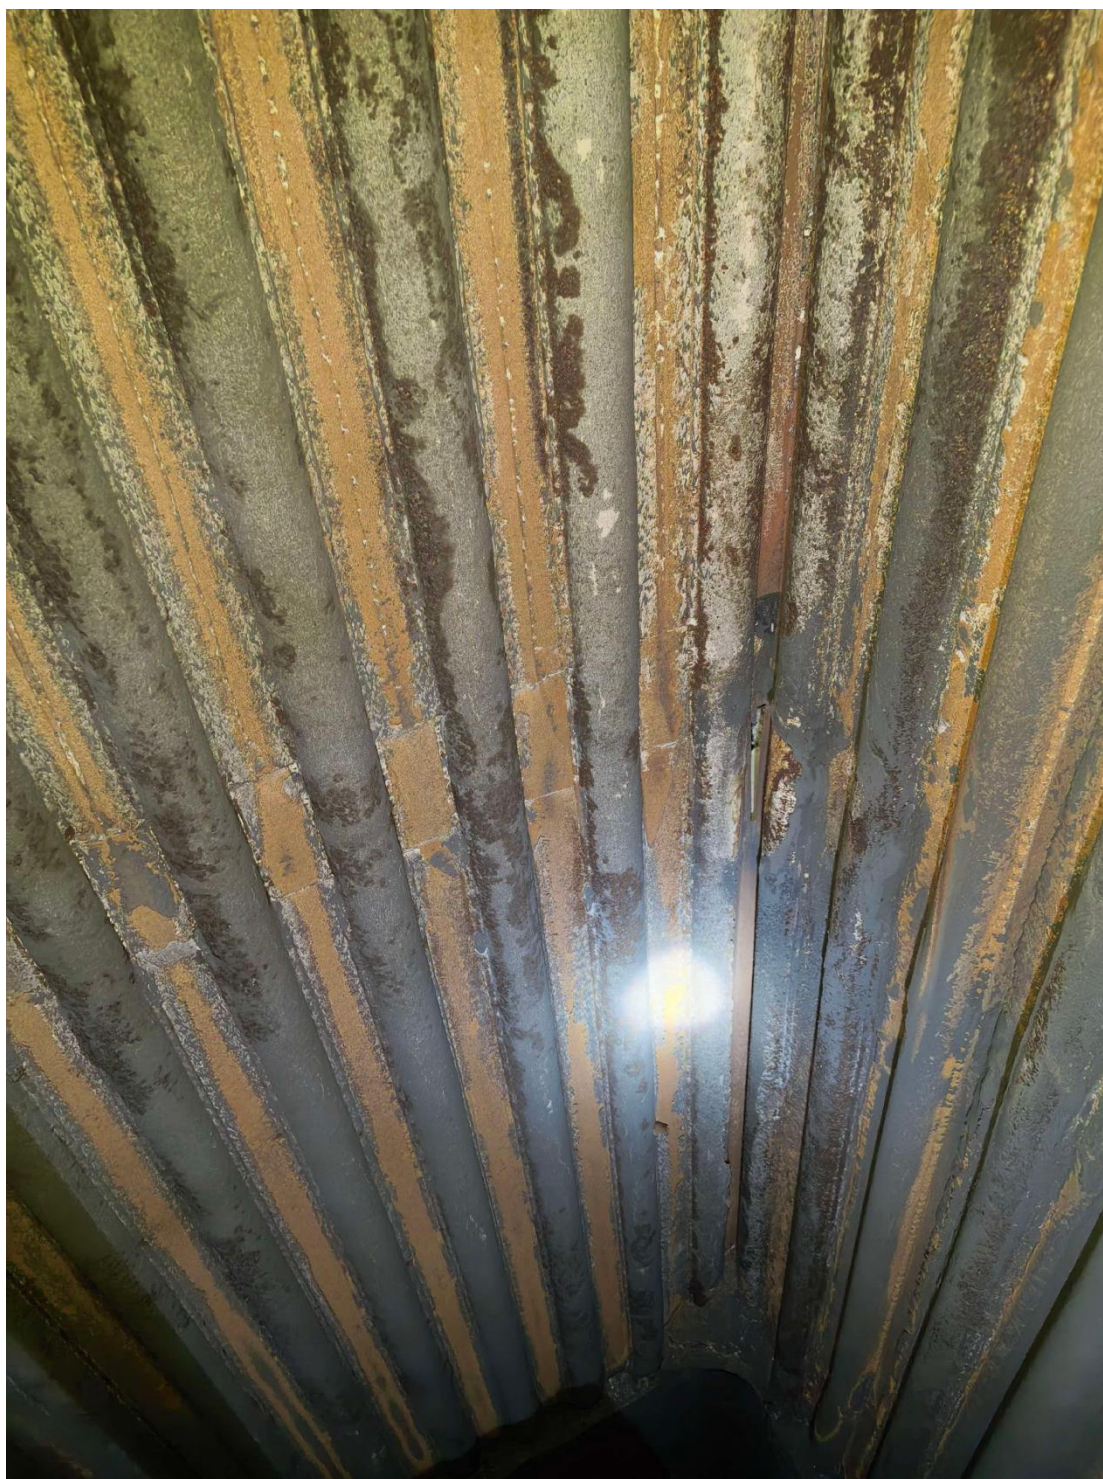
七：锅炉水冷壁：检查#1 炉两处鳍片磨损破裂
